# BUILDING SURVEY REPORT

**PROPERTY**            SAMPLE SURVEY  
NOT FOR DISTRIBUTION  
COPYRIGHT SKYLINE  
SURVEYORS LTD

**SURVEY DATE** 1 Oct 2025

**REF**                    BS SAMPLE

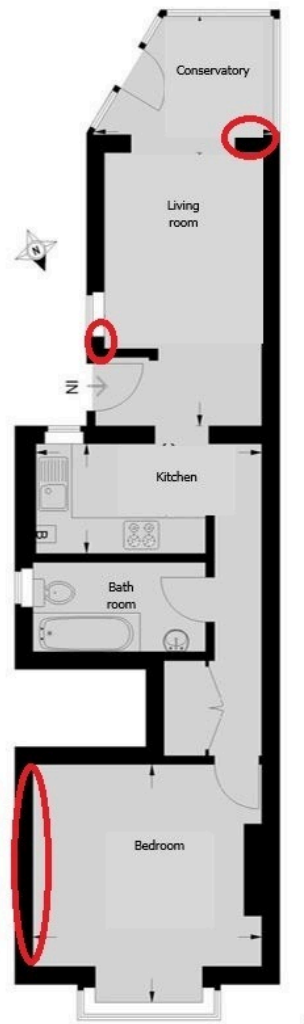
Floorplan

Areas highlighted in red indicate where high moisture readings were recorded, suggesting that dampness is present. Dampness is also likely to be present in other areas.

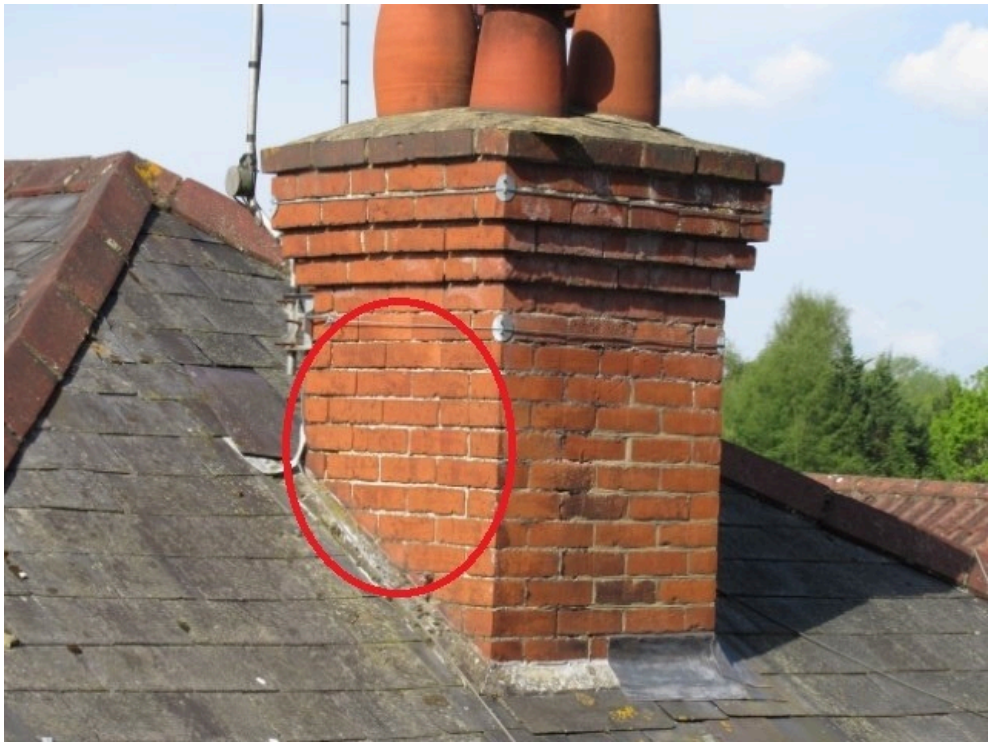
Worn pointing on the left side

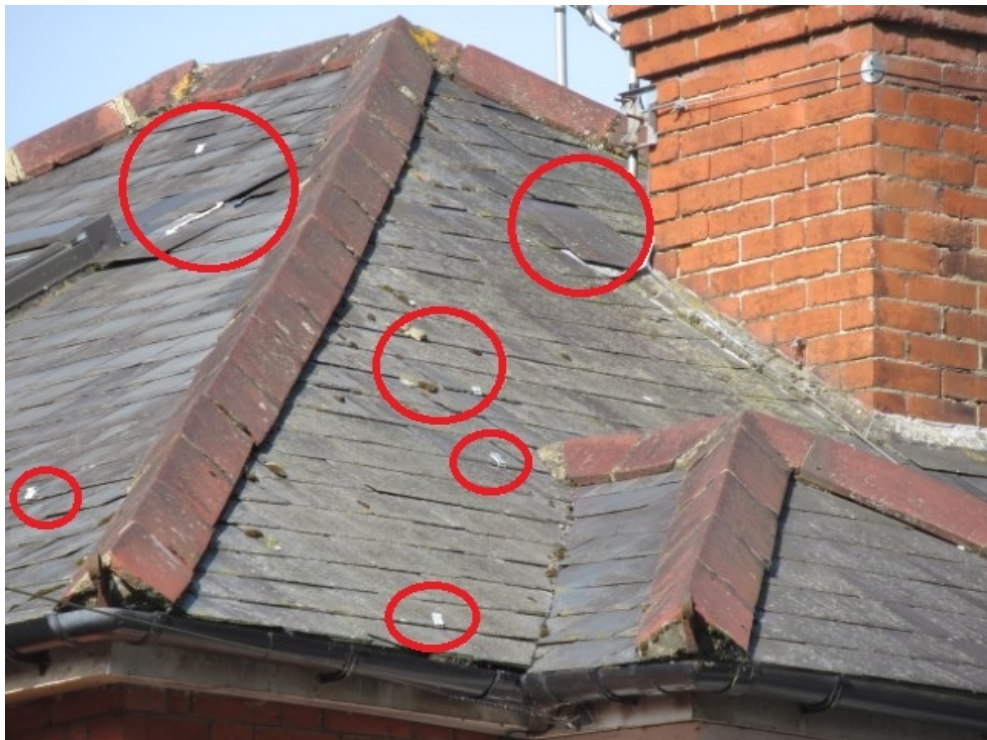
Slipped slates and tingles on the front and left side pitches

| COMPANY<br>THUMBNAIL<br>HERE | 4.2 Roof Coverings | Condition<br>rating | 3 |
|---|---|---|---|
| <b>Action Required</b> | <p>Slate roofs have a lifespan of around 100 years and so it should not be unexpected that this roof is now close to the end of its expected service life.</p> <p>It is likely, therefore, that the entire roof will need replacing in the near future and that this work will be at the significant cost. You should budget accordingly.</p> <p>Whilst it is possible to continue replacing slipped slates, the number that have already been replaced is clear evidence that the roof is due for replacement.</p> | | |

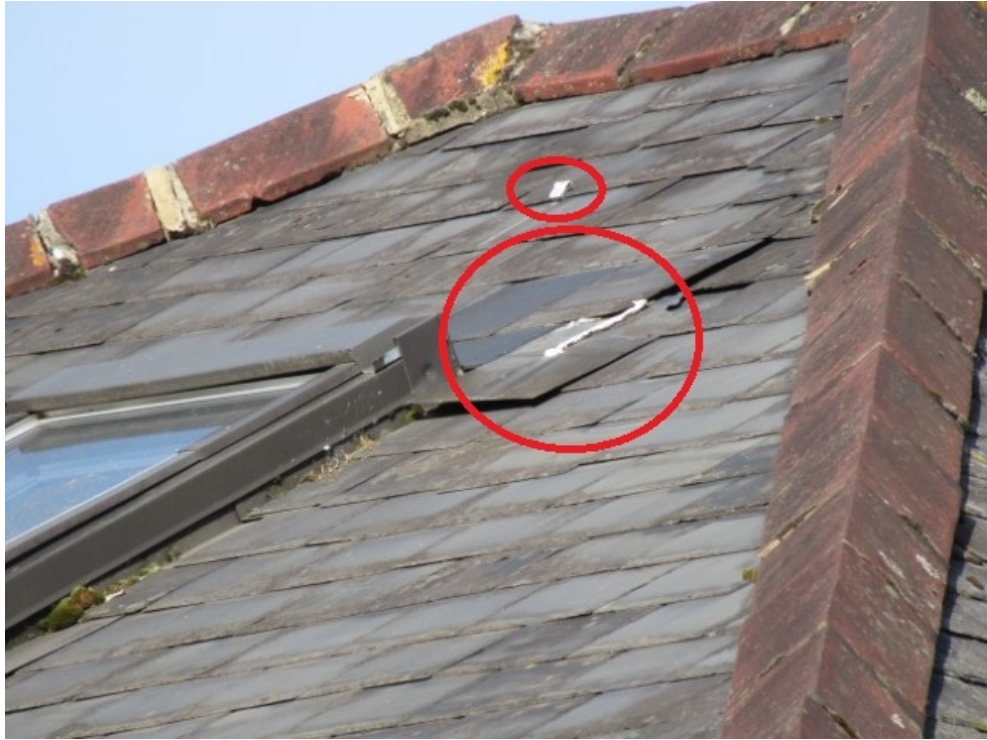
Slipped slates and tingle on the left side pitch

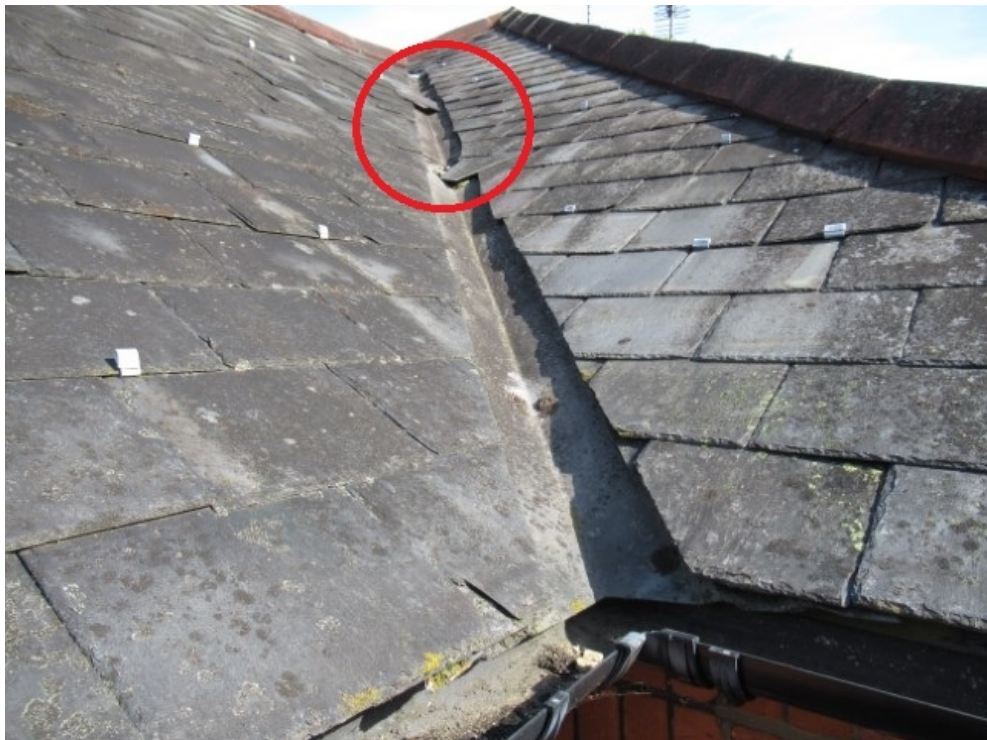
Slipped slates in the rear valley

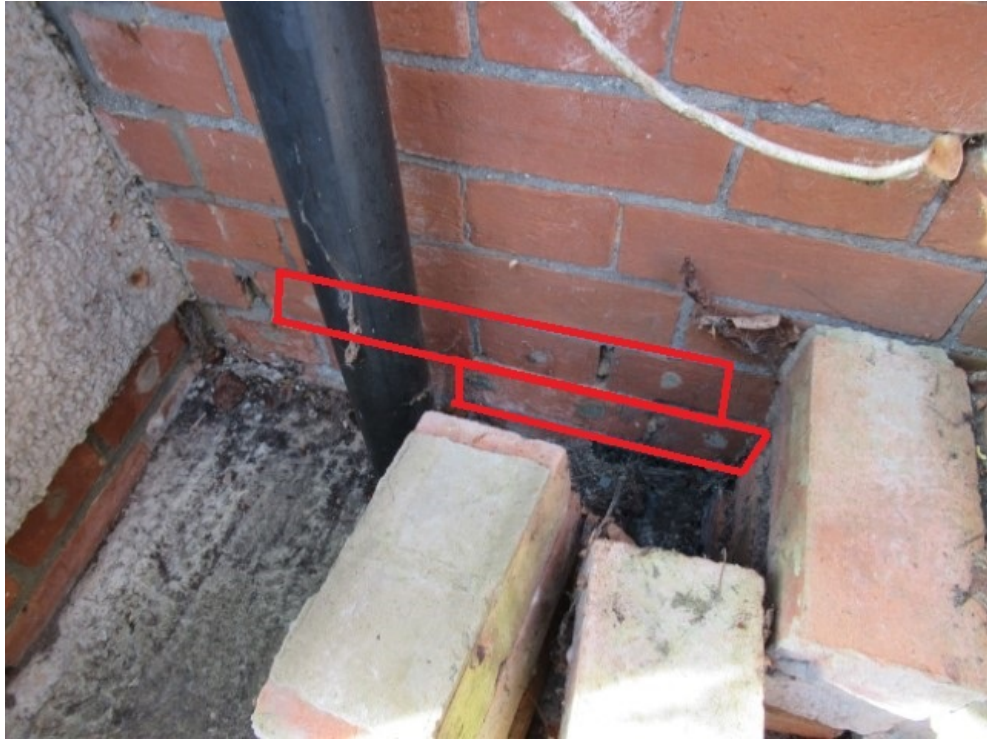
Double layer of injected DPC to the right of the bay at the front

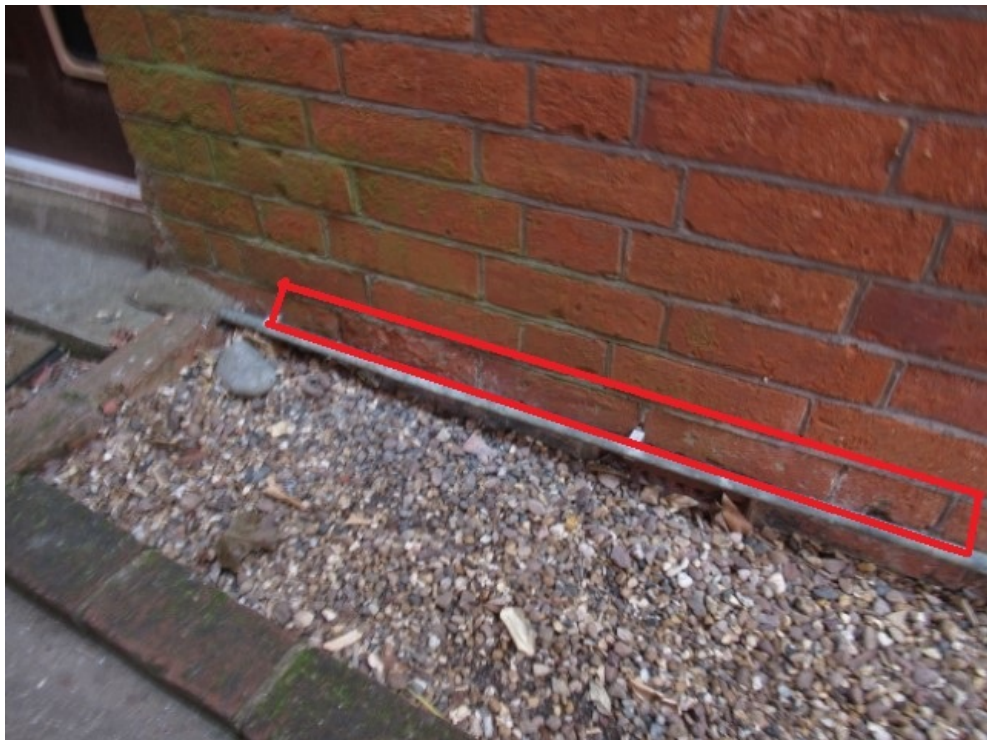
Injected DPC holes on the left side wall

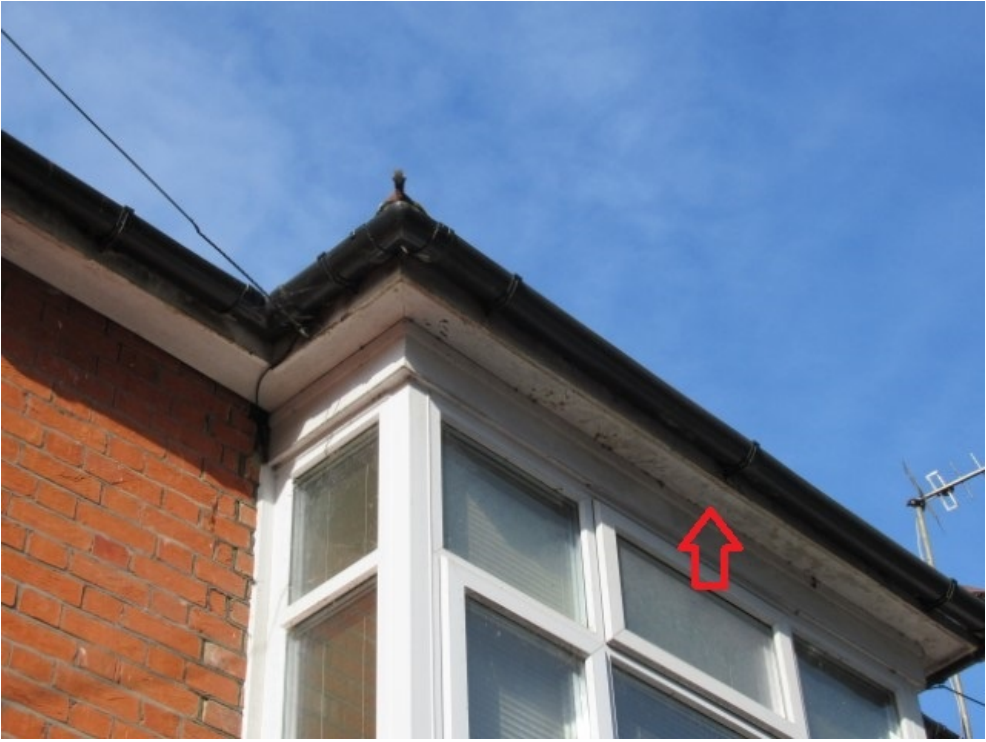
| COMPANY<br>THUMBNAIL<br>HERE | 4.6 External Joinery and Finishes | Condition<br>rating | 2 |
|---|---|---|---|
| | <div data-bbox="379 981 1369 1720"> </div> <p>Poorly maintained soffit at the front</p> | | |

| COMPANY<br>THUMBNAIL<br>HERE | 4.6 External Joinery and Finishes | Condition<br>rating | 2 |
|---|---|---|---|
| <b>Action<br/>Required</b> | <p>All of the external joinery requires redecoration. This work should be carried out within the first 12 months of occupancy of the property.</p> | | |

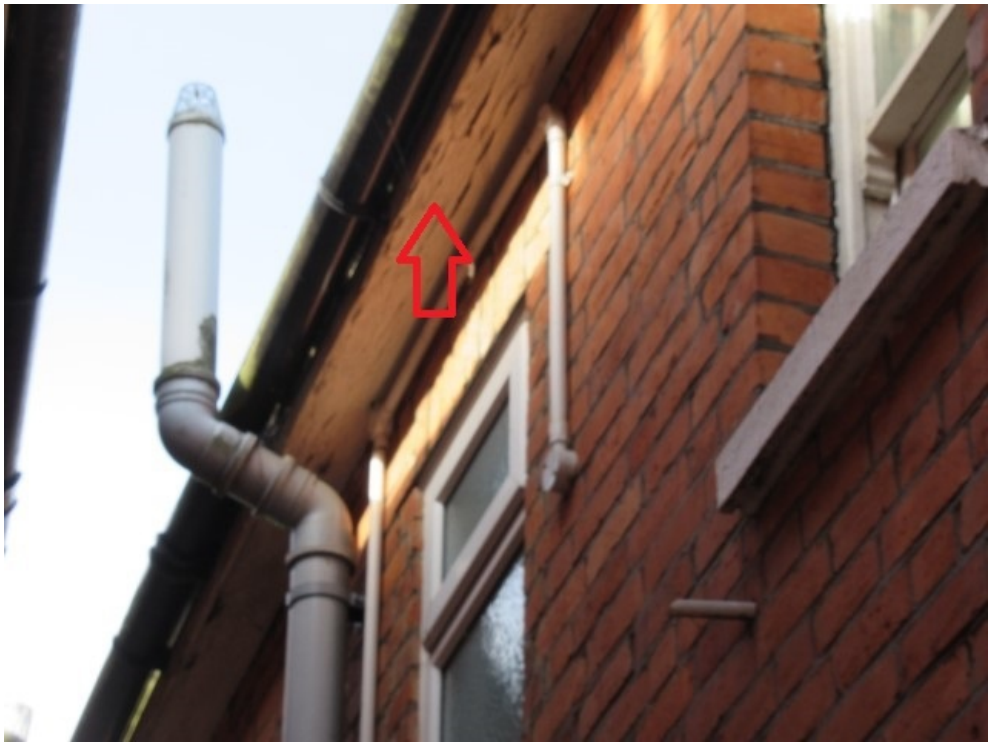
Poorly maintained soffit on the left side

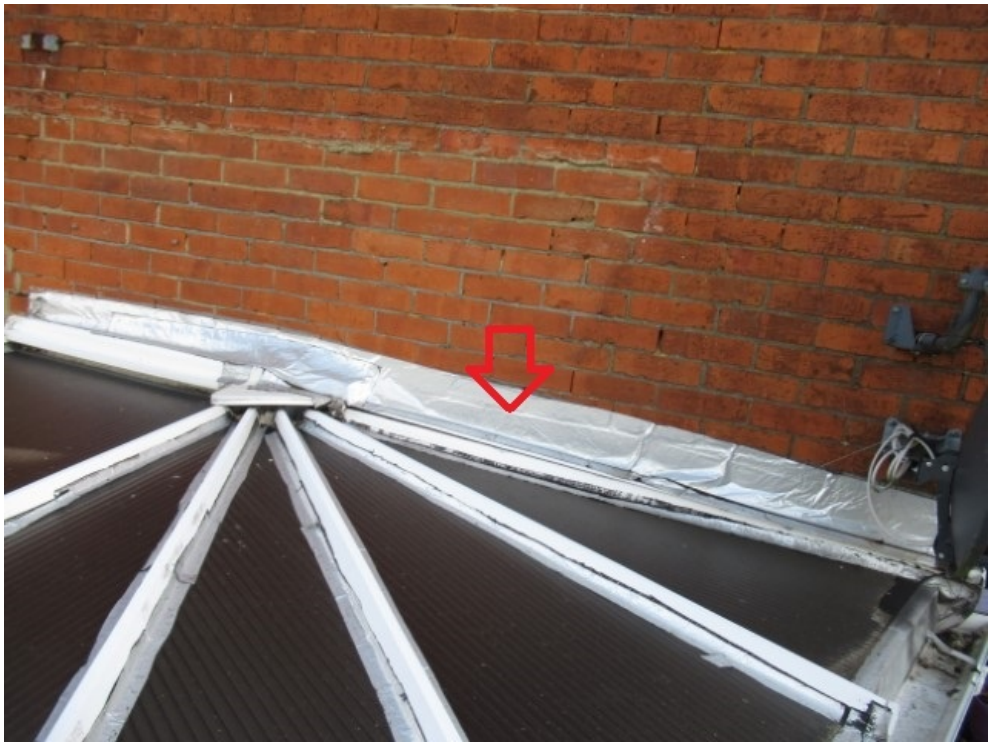
Flashband flashing

| COMPANY<br>THUMBNAIL<br>HERE | 4.7 Conservatories and Porches | Condition<br>rating | 3 |
|---|---|---|---|
| <b>Action<br/>Required</b> | <p>The evidence suggests that the conservatory is probably at the end of its useful life. As a minimum the flashing between the roof and the house requires replacement with an inset lead flashing, and the floor covering should be removed to allow for further inspection of the floor structure, to determine whether it is in a serviceable condition.</p> <p>Parts of the wall finish will also need to be removed to allow for investigation of pathways by which dampness is affecting the internal wall.</p> | | |

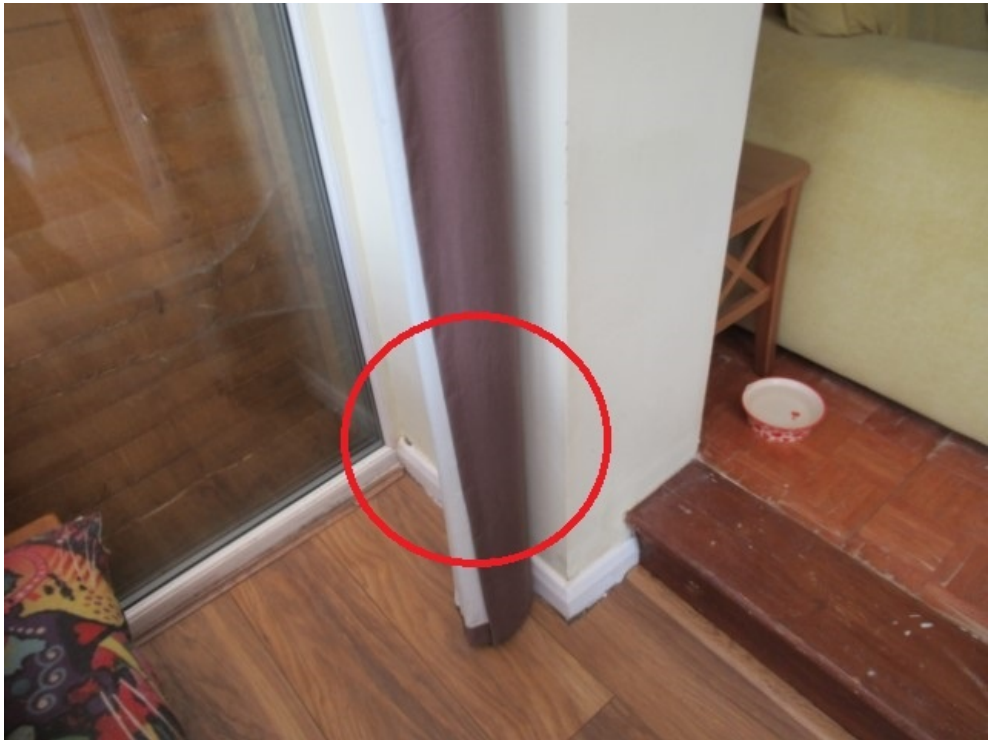
Area of dampness

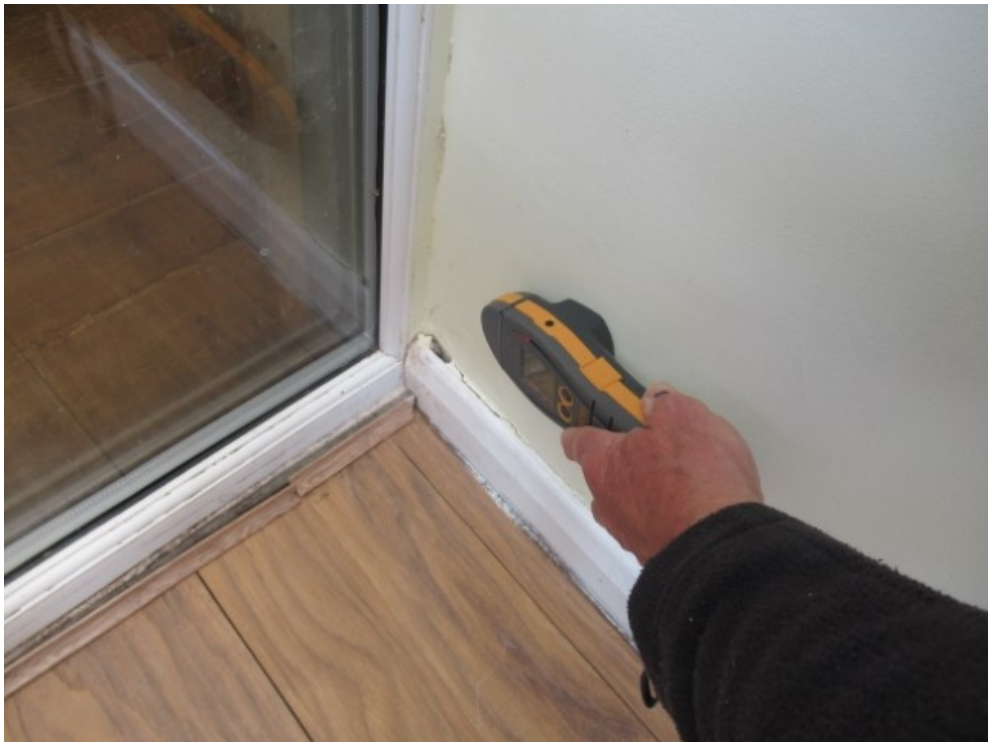
High moisture reading in the conservatory

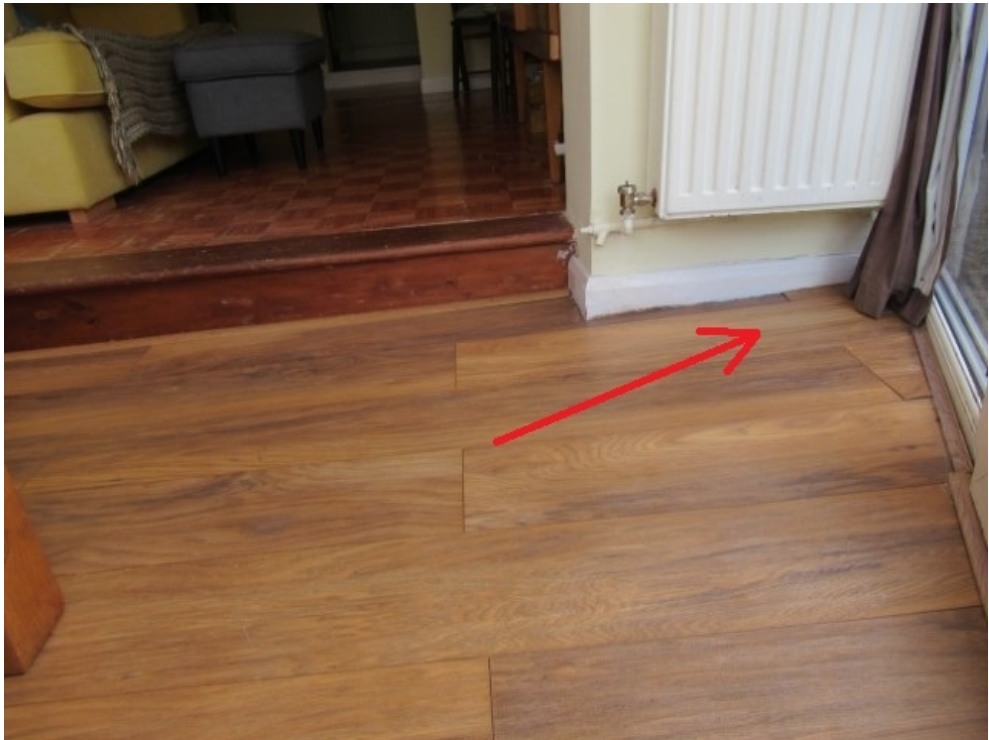
Floor slopes up to the junction with the house

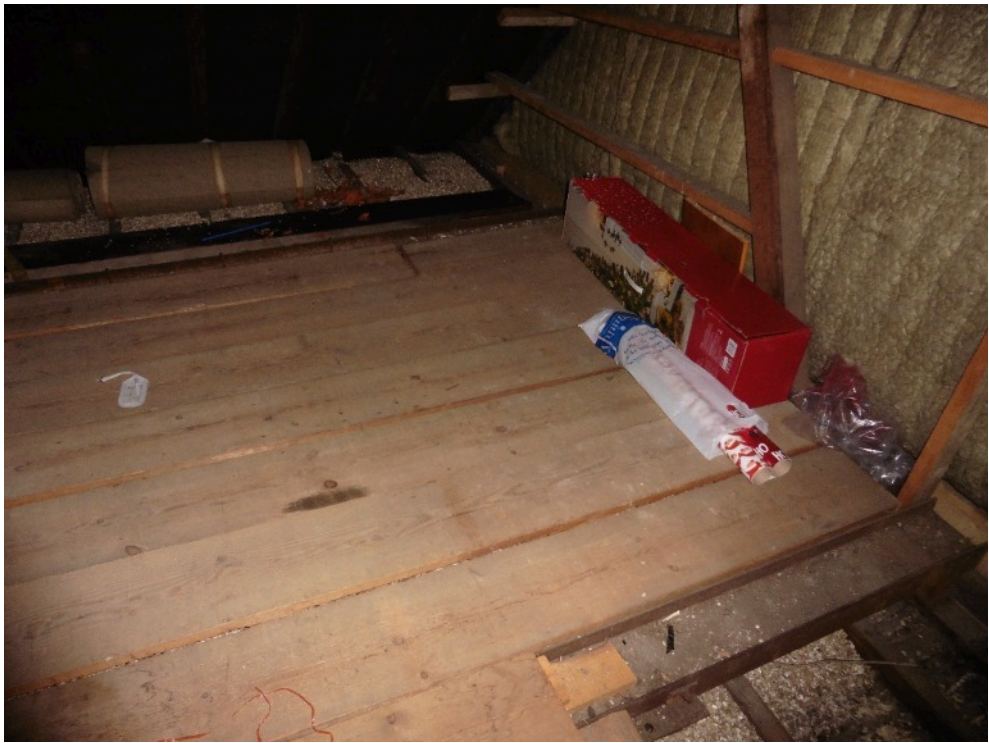
Loose floor boards

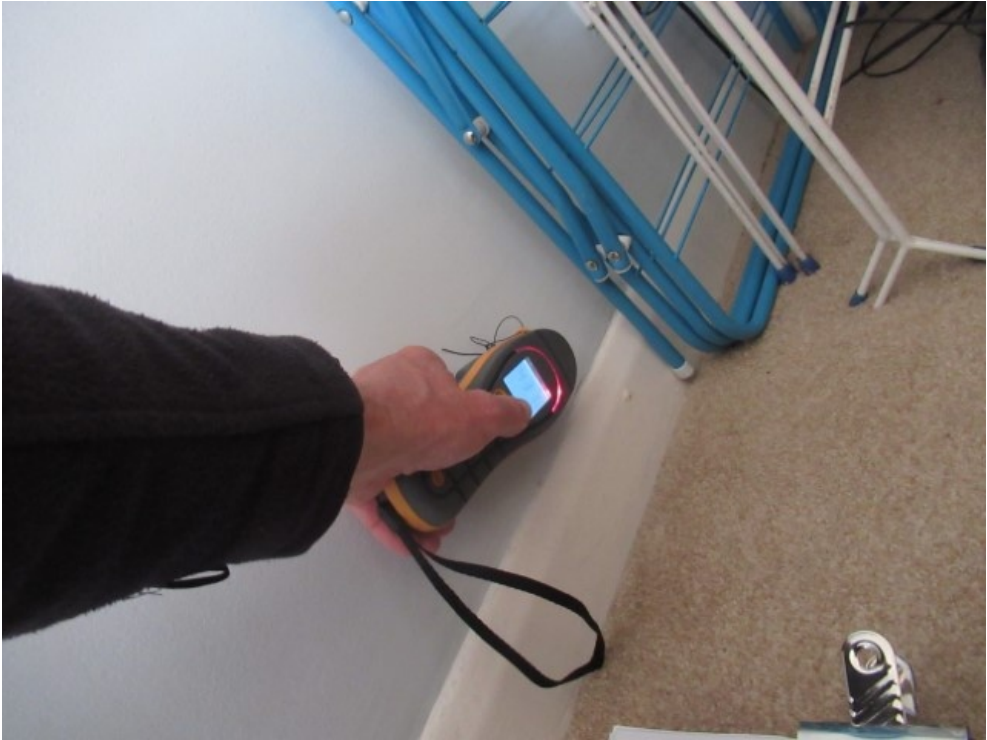
| | <div></div> <p>High moisture reading on the left side wall of the bedroom</p> |

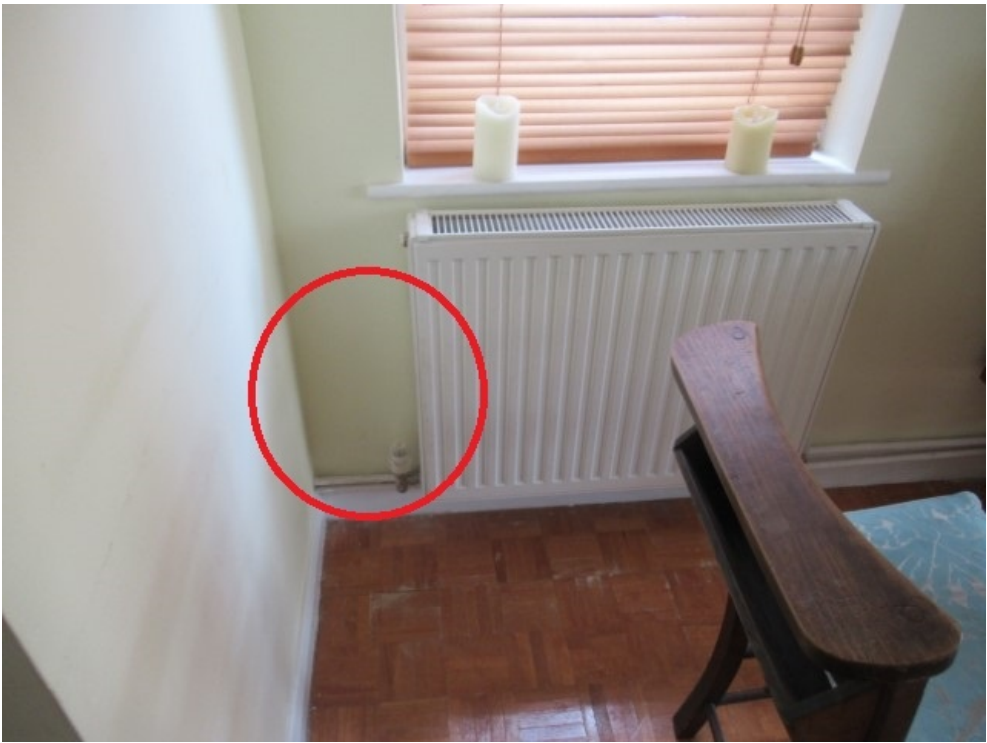
Area of dampness in the living room

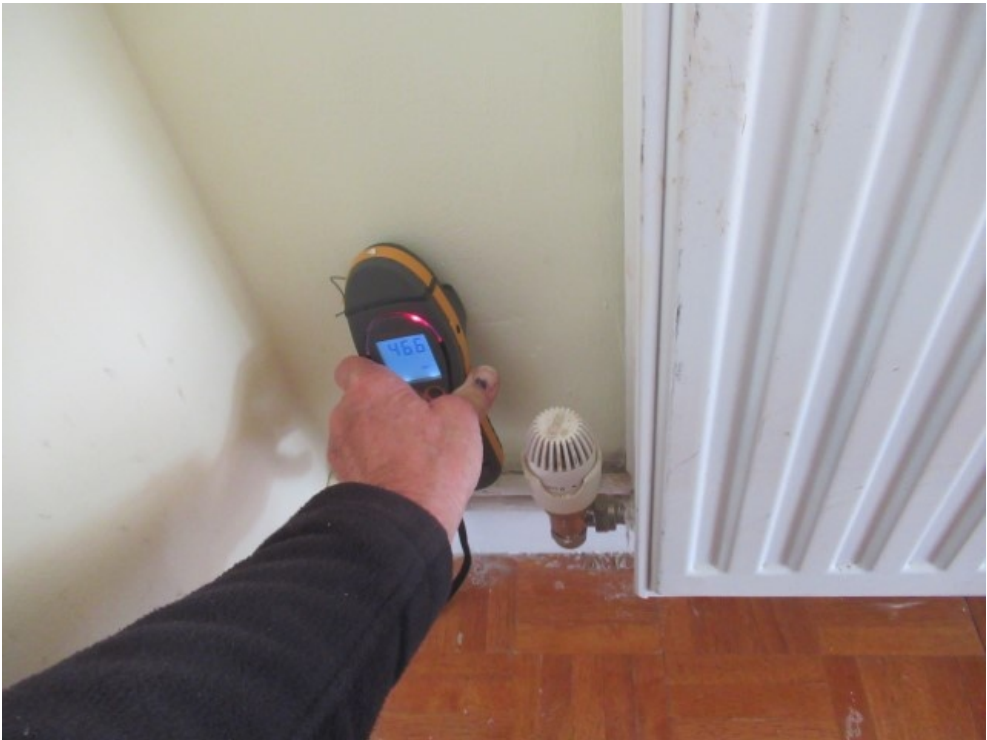
High moisture reading in the living room

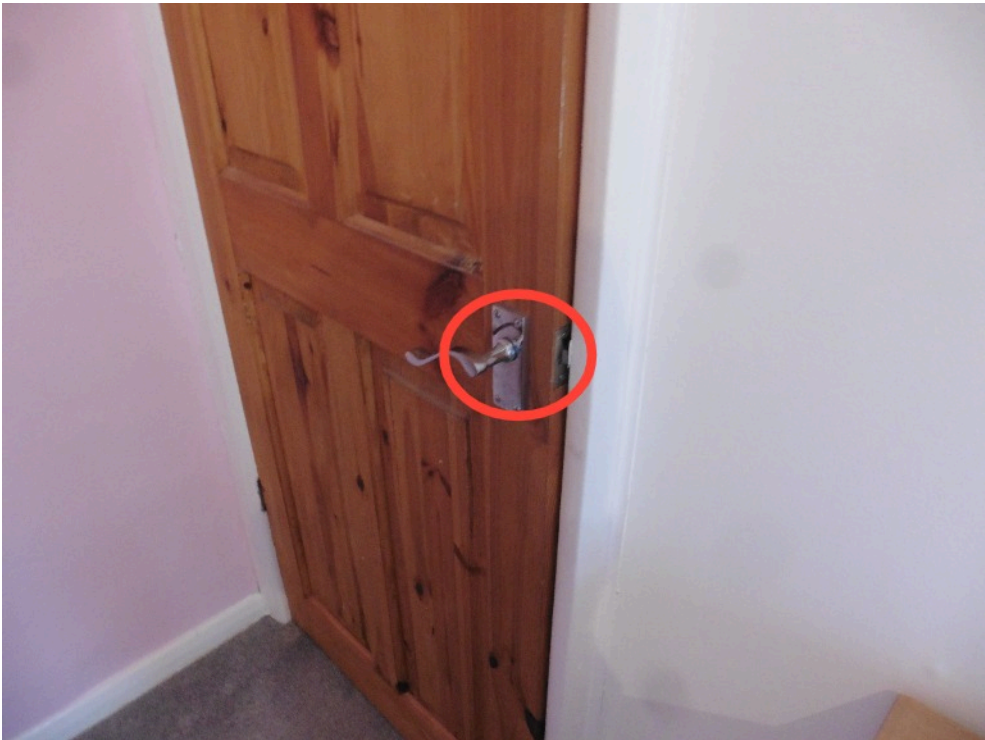
| COMPANY<br>THUMBNAIL<br>HERE | 5.7 Internal Joinery | Condition<br>rating | 1 |
|---|---|---|---|
| | <p data-bbox="651 1823 1094 1852">Inoperative door catch to bedroom 2</p> | | |

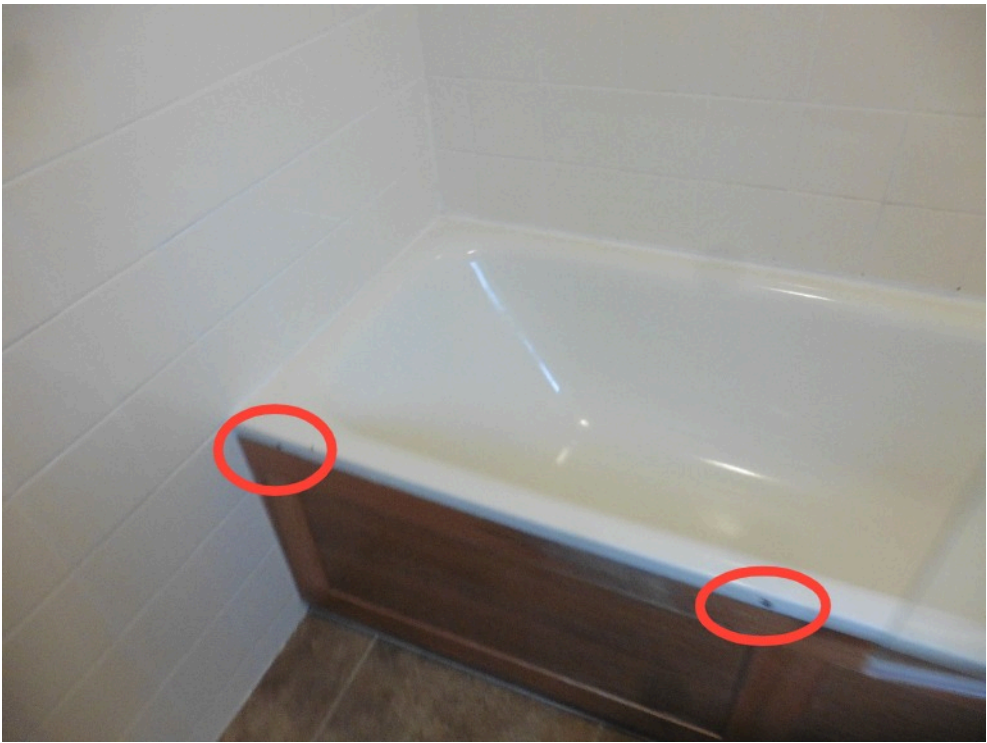
Chipped enamel on the bath

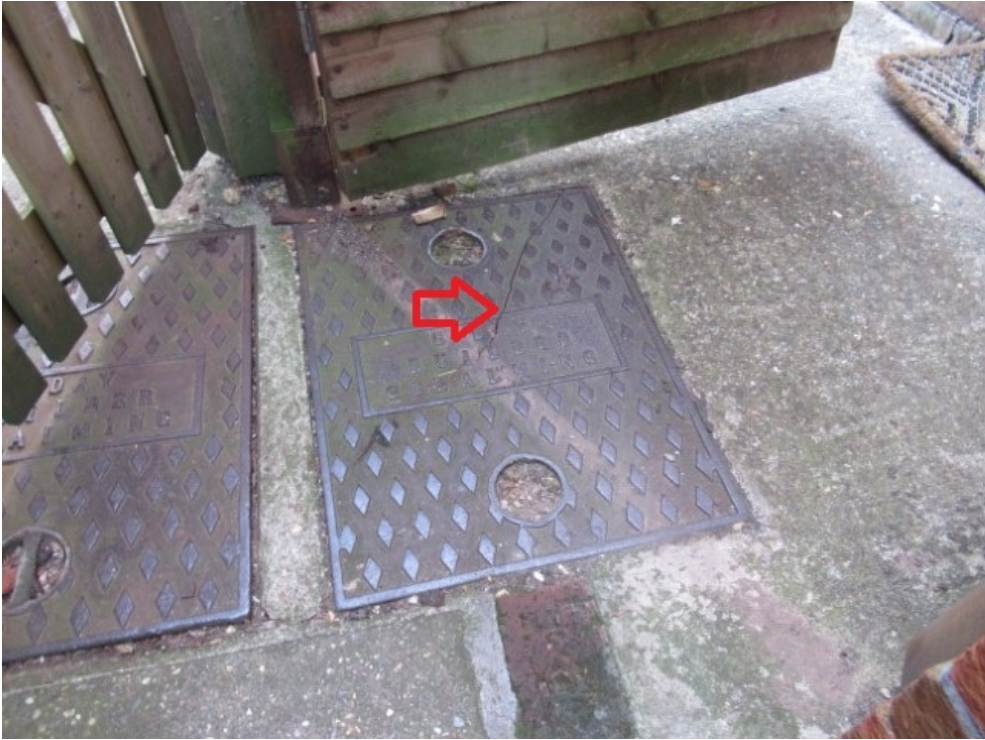
| | <p>Cracked lid of the chamber by the side gate</p> |

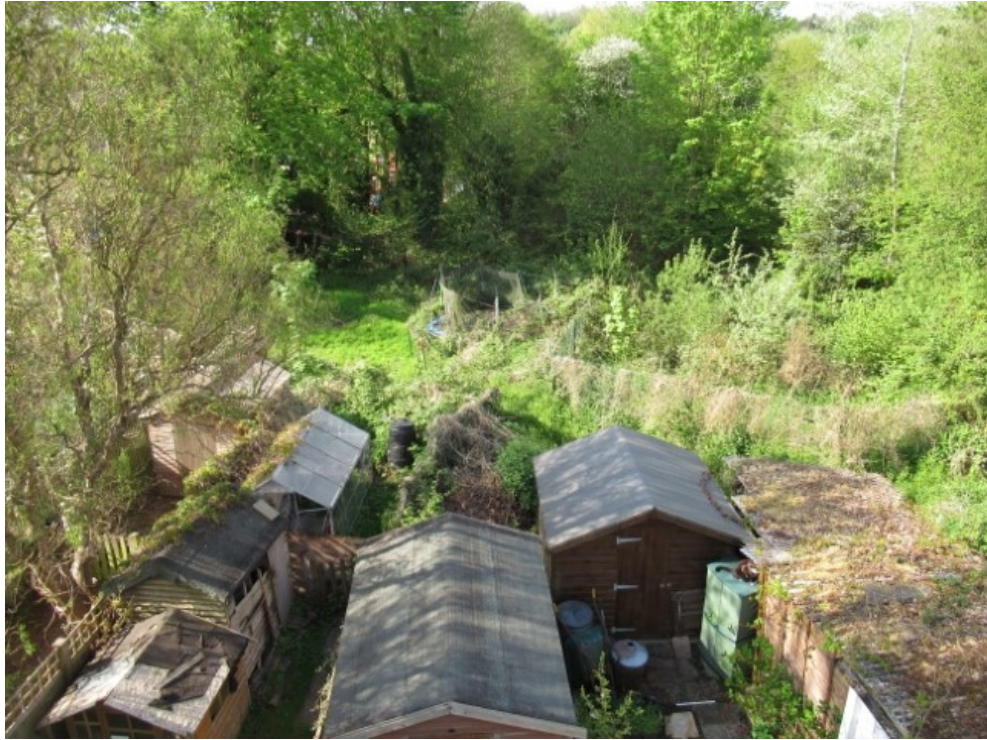
View of overgrown area to the rear of the shed

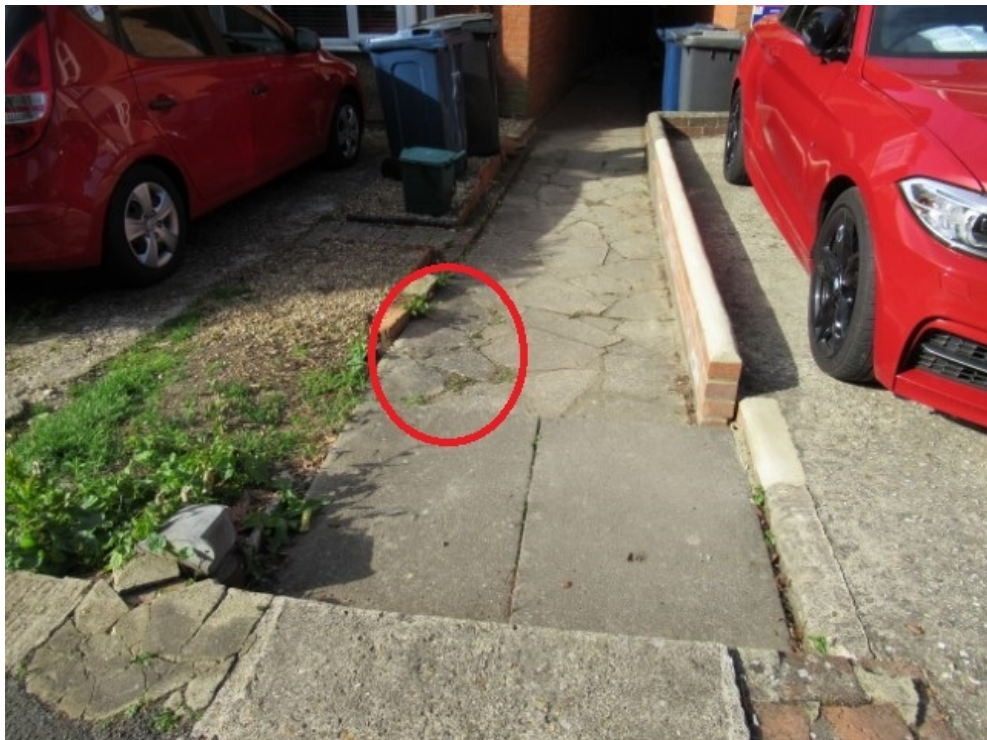
Uneven paving on the shared path at the front

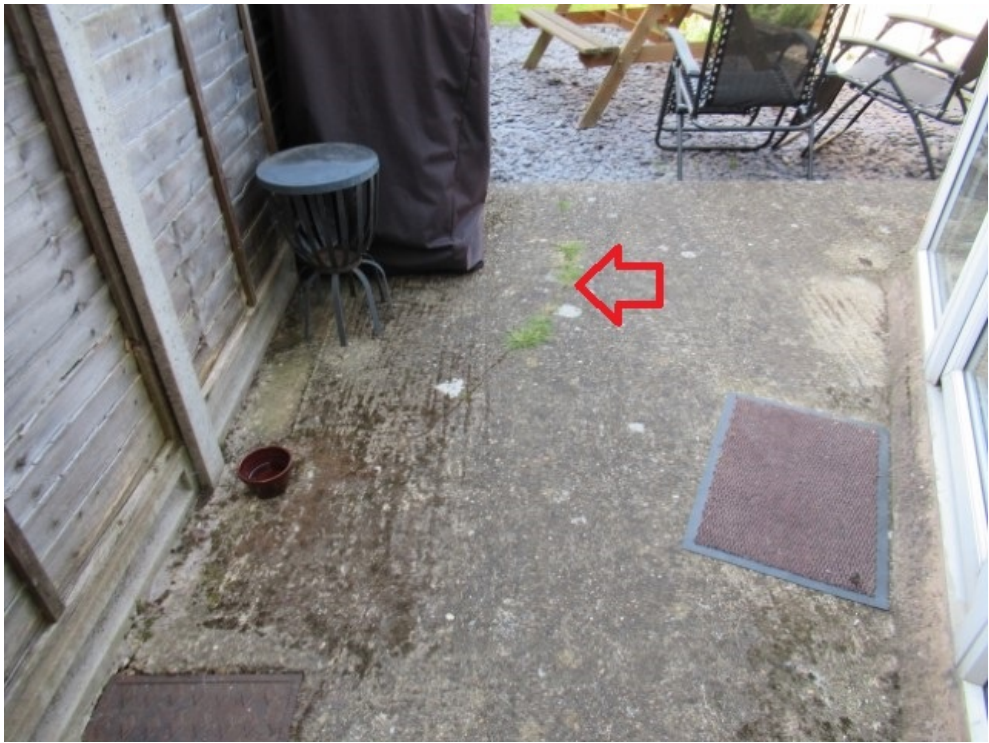
Settlement cracking of the rear patio

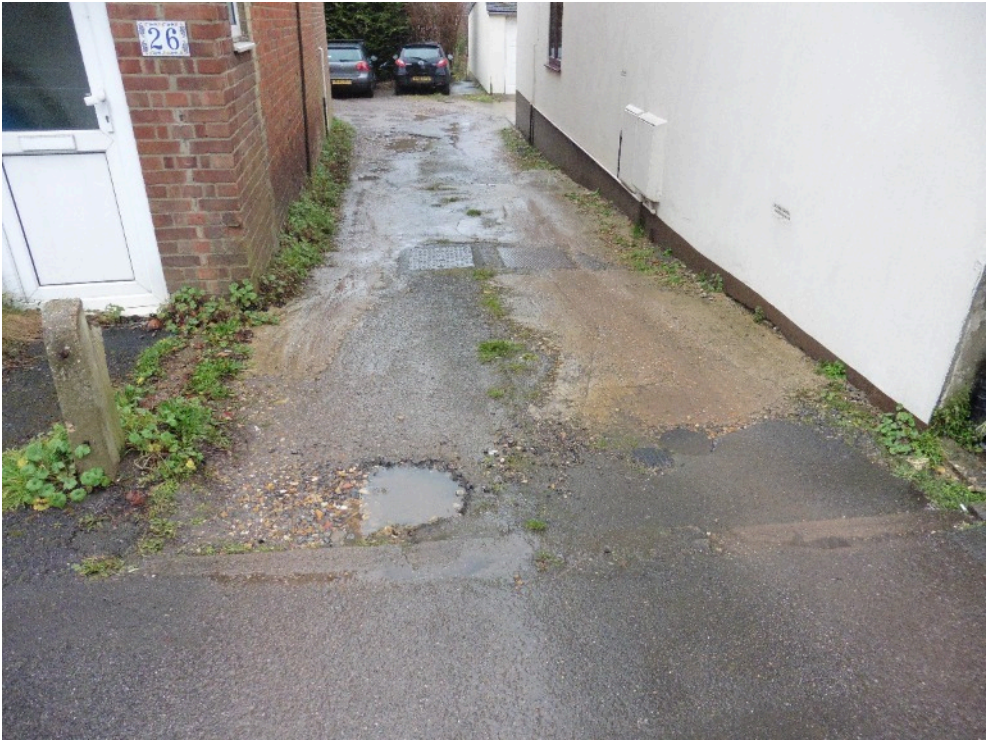
| | <p>Shared access from the road is potholed and uneven</p> |
