# Landlords Decent & Safe Home Review

FORMING PART OF SURVEY REPORT REF BTL SAMPLE

**PROPERTY** SAMPLE SURVEY

**SURVEY DATE** 1 Oct 2025

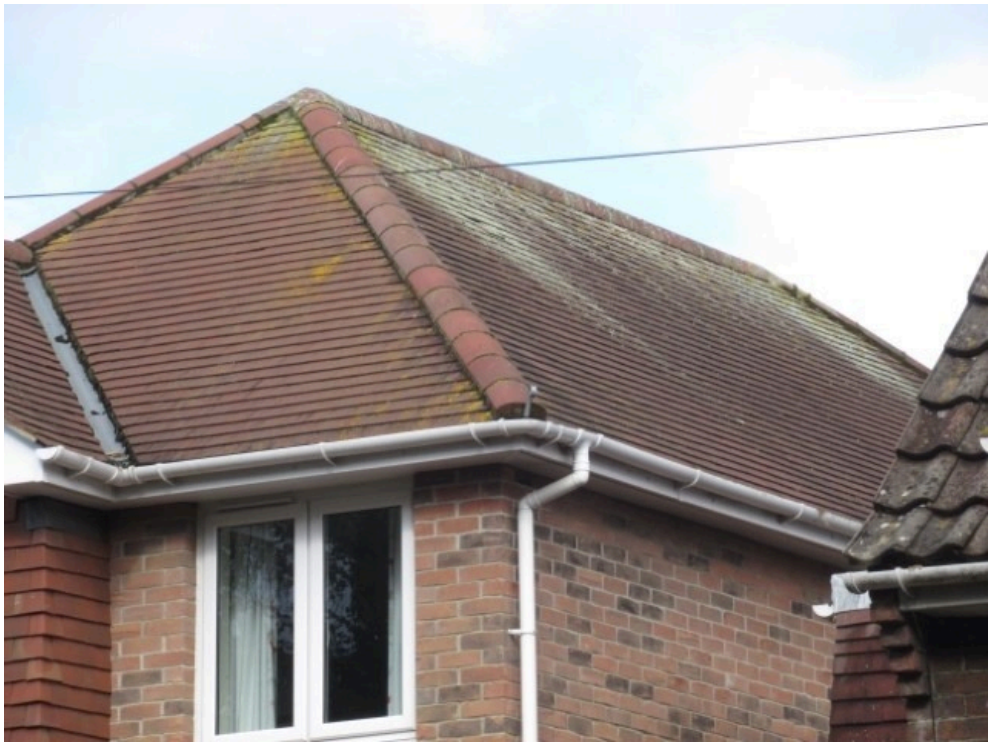
| Condition | <p>No significant defects were noted and the roof was found to be structurally stable.</p> <p>No evidence was seen of unusual sagging or other movement which might indicate that the structure is failing.</p> <p>There are no significant numbers of slipped, missing or broken tiles visible on the roof pitches.</p> <p>Some moss growth was evident and this should be cleared as a matter of routine maintenance to prevent over-weighting the roof structure.</p> <p>The lead flashing that seals the polycarbonate roof of the rear living room extension has become dislodged to the right side and has been secured with tape. If not properly seated this will leak and so the flashing should be removed and reset. This may require complete replacement of the flashing. Although this is not major work, it should be carried out as soon as possible after occupation, and preferably before the next winter.</p> <p>Carry out normal maintenance including removal of moss build-up.</p> <p>Any slipped, missing or broken tiles on the roof pitches should be repaired and replaced.</p> <p>You should carry out a thorough visual inspection at least once a year, ideally in the Spring to identify and repair any damage that could have been caused by winter weather.</p> <p>Polycarbonate roofs, such as that to the rear, have a limited lifespan of, perhaps 10-20 years, and will require regular replacement.</p> | | |

Front and right side roof pitches

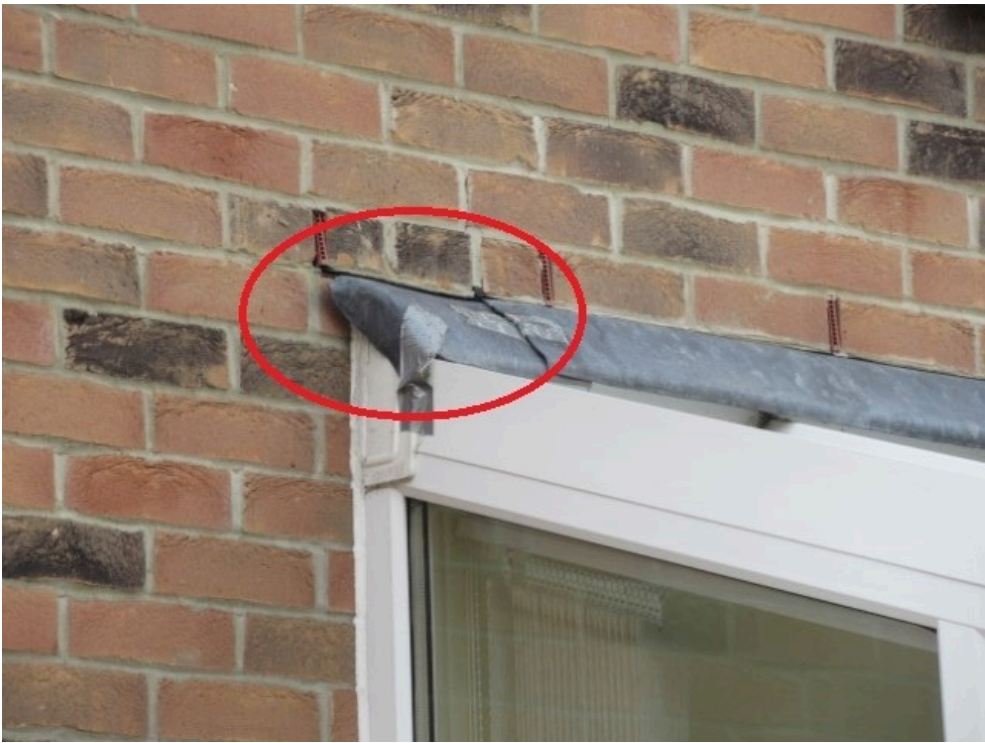
Loose and taped flashing for the living room extension roof at the back

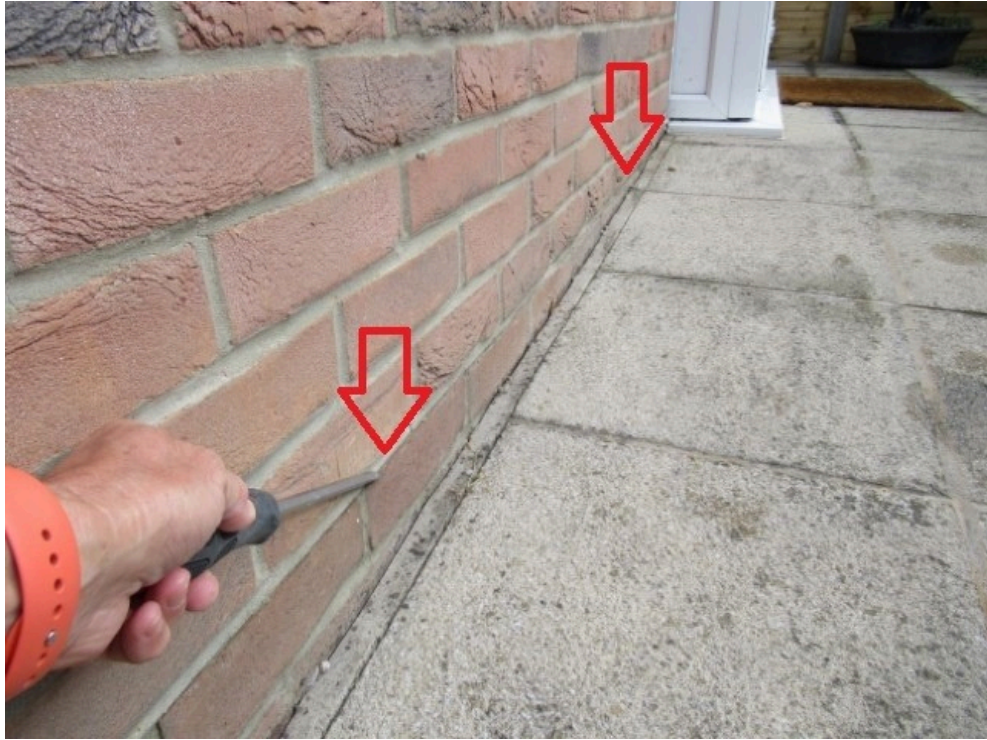
Level of damp proof course at the front is below the paving around the front porch viewed from the front

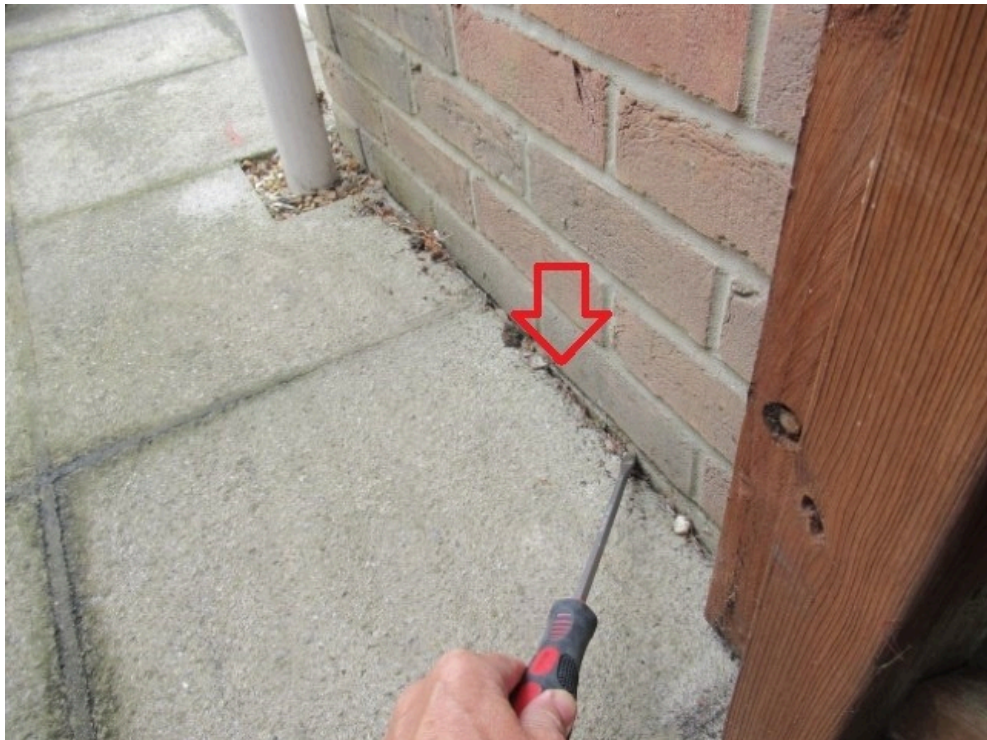
Level of damp proof course on the right side adjacent to the porch

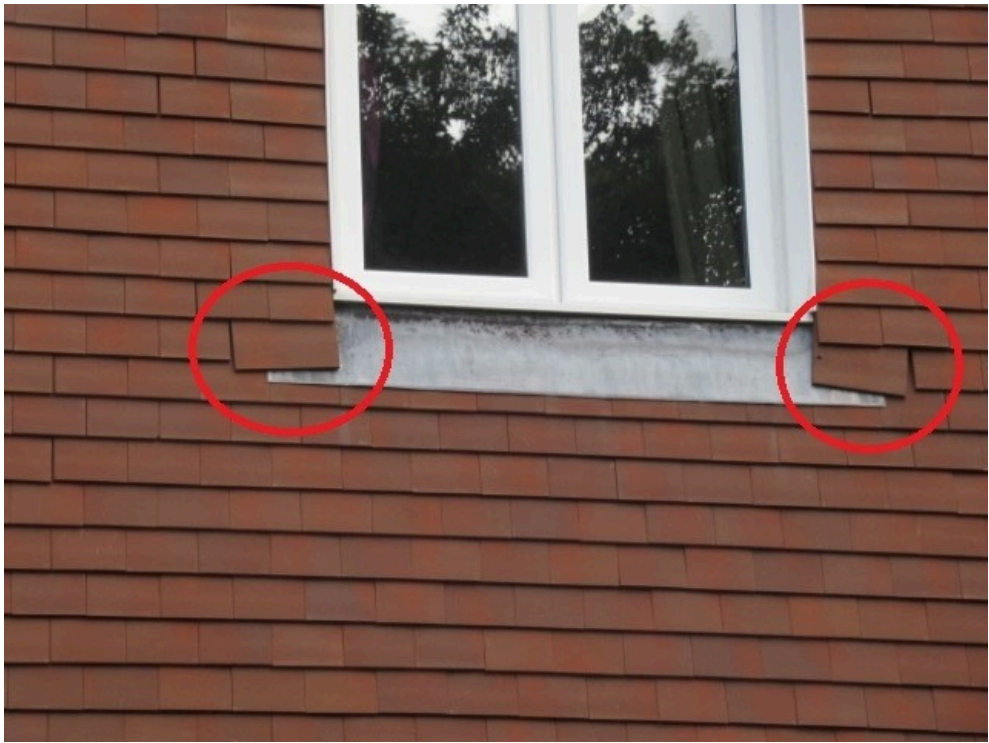
Misaligned tiles at the front

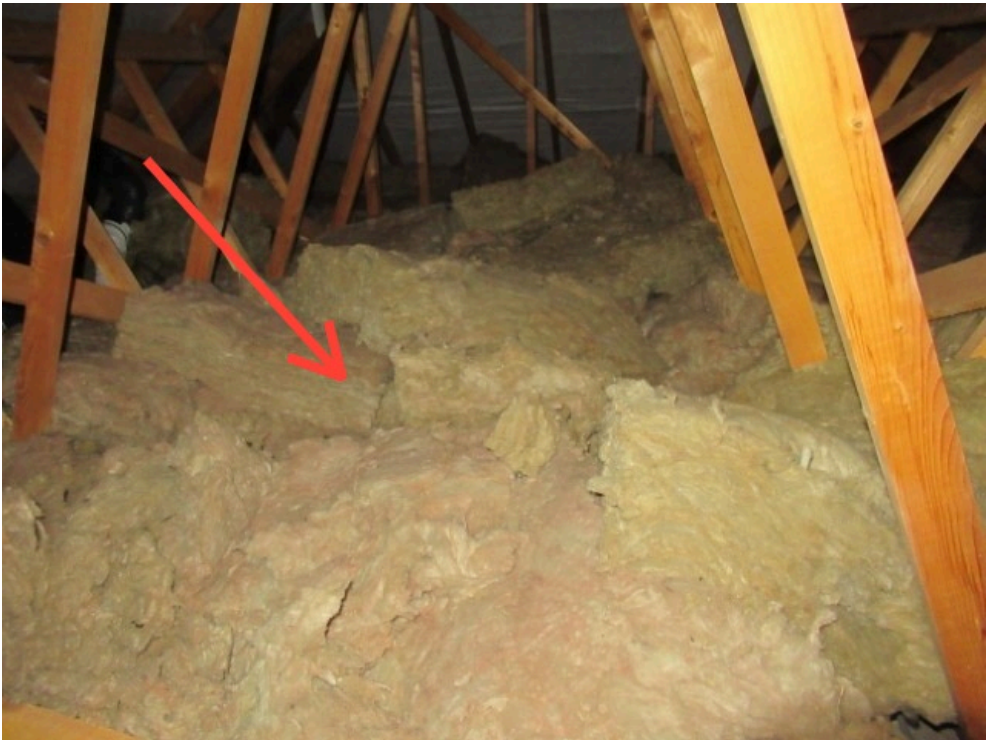
Uneven insulation

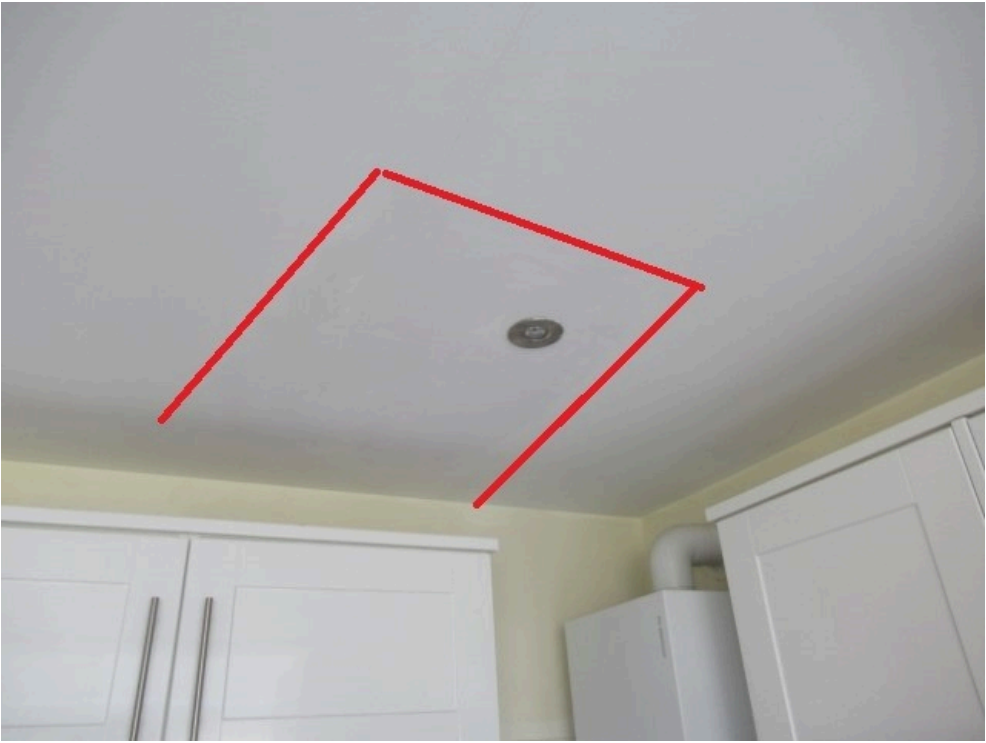
| COMPANY<br>THUMBNAIL<br>HERE | 5.2 Ceilings | Condition<br>rating | 1 |
|---|---|---|---|
| <b>Condition</b> | <p>No significant defects were noted.</p> <p>No evidence was seen of any unusual unevenness, cracking, bowing or other failure.</p> <p>A stain on the kitchen ceiling, near to the boiler, is immediately below the en-suite shower room. The sellers indicated that the stain was caused by water escaping from the shower after the door was left ajar. While it is assumed that this is a genuine explanation, of course, it cannot be confirmed. However nothing was seen to suggest that this is an ongoing matter.</p> <p>Some cracking of the ceiling finishes was noted. These cracks are primarily along the lines of plasterboard joints and are unlikely to be symptomatic of undue movement of the property.</p> <p>Normal maintenance is required, including filling and redecorating cracks as necessary.</p> | | |
| | <p>Staining in the kitchen near to the boiler</p> | | |

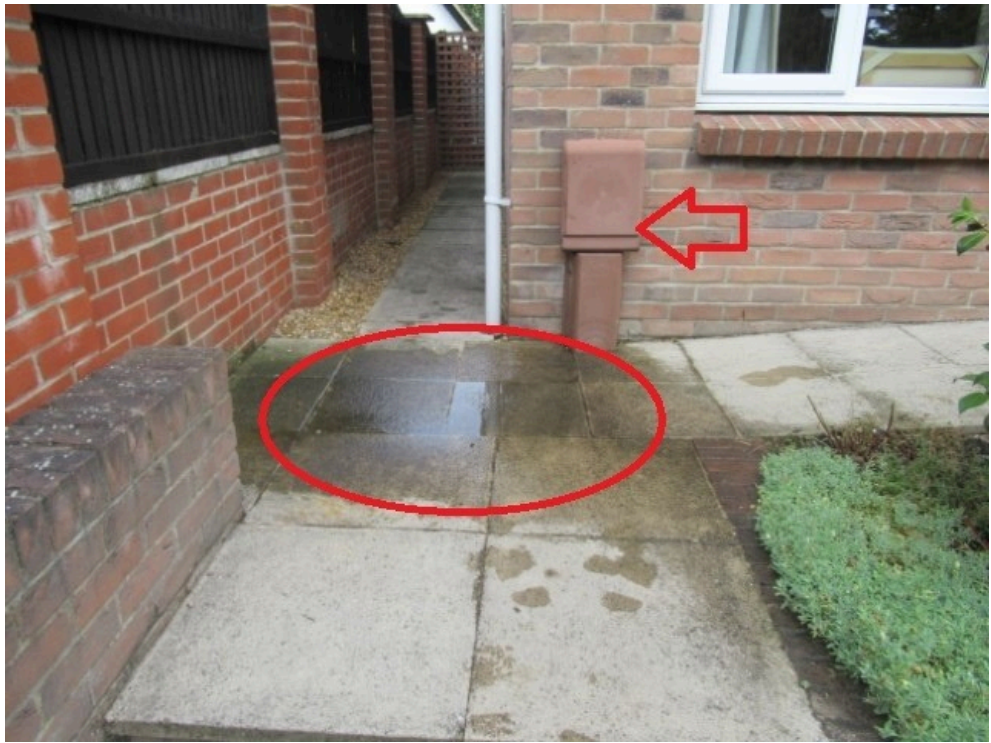
| COMPANY<br>THUMBNAIL<br>HERE | 6.3 Water | Condition<br>rating | 3 |
|---|---|---|---|
| <b>Condition</b> | <p>At the front of the house a wet area was noted on the paving in the area immediately of the water meter housing. This could be caused by a leak from the main water supply to the house. If this were the case then a leak of this type can lead to the ground unstable, causing the house to subside as the foundations fall into the ground which has been washed away.</p> <p>The sellers indicated that they had had the installation inspected by the water authority and that it had been confirmed that the wetness was not due to a leak but it was an area which took longer to dry after rainfall. Indeed, it had rained in the days prior to the survey inspection which could corroborate this version of events.</p> <p>However, as it is impossible to confirm this to be the case, from a single inspection of the property, further investigation is recommended, initially by enquiries of the sellers, until it can be satisfactorily proven that no leak is present.</p> <p>These enquiries are considered to be of an urgent nature and should be carried out before exchange of contracts.</p> <p>If it is the case that the wetness is simply due to rainfall, then some further inspection be made to identify the pathway by which rain runs off surfaces above this whether some other factor may be causing it.</p> <p>In all other respects the installation was found to be in a serviceable condition. Hot water was obtained from all hot tap outlets, and the flow of water was found to be within a normal range. Check the installation for evidence of leaks or other defects on a regular basis i.e. approximately every 6 months, or sooner. Leaks most often occur at pipe joints and where pipes are subject to movement or physical damage, such as airing cupboards, roof spaces and under sinks.</p> | | |

Wet path adjacent to water meter housing

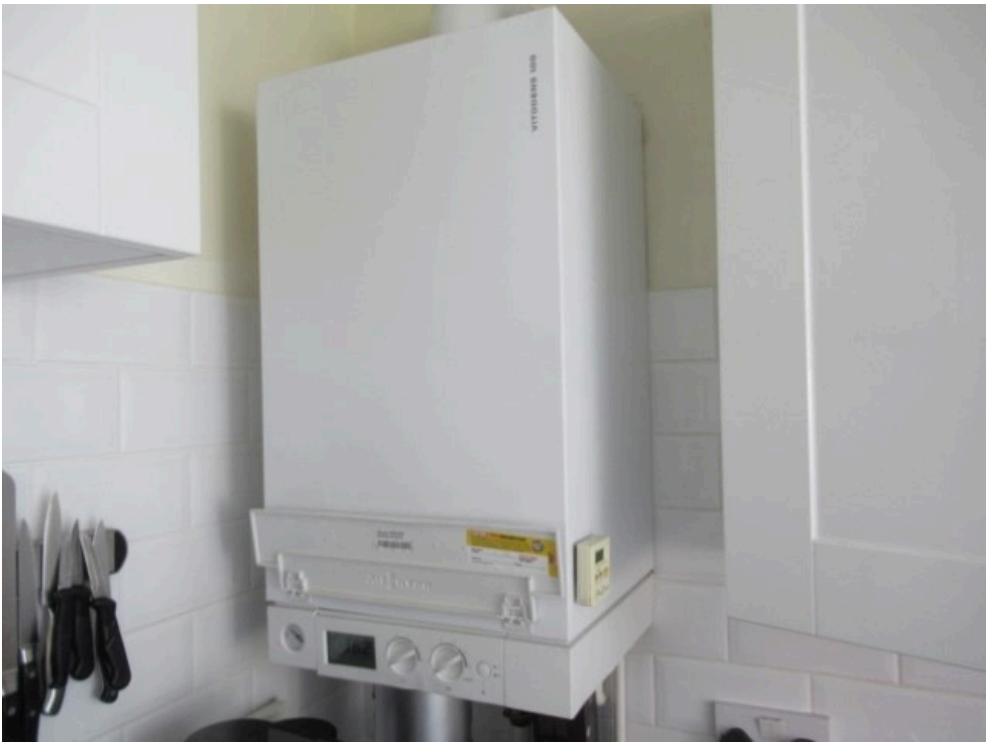
Boiler

| COMPANY<br>THUMBNAIL<br>HERE | 6.4 Heating and Cooling | Condition<br>rating | HS |
|---|---|---|---|
| <b>Condition</b> | <p>No evidence was available to suggest that the boiler has been recently serviced. However, the sellers indicated that it was due to be serviced in the days immediately following the survey inspection.</p> <p>The boiler is that which was installed at the time of construction of the house, and so is around 7 years old.</p> <p>Under normal circumstances a modern boiler will last for 15-20 years before requiring replacement.</p> <p>Gas Safe recommends that all gas appliances and boilers are inspected and serviced according to manufacturer's guidance, but at least once a year. A gas installation can look to be in a safe condition, but serious defects may be hidden, some of which can kill. It is therefore considered to be essential that you commission an inspection of the gas/heating installation prior to purchase of the property, unless you are provided with verifiable evidence that such an inspection has recently been carried out by a competent person.</p> <p>You can get more information, or find a Gas Safe registered engineer <a href="https://www.gassaferegister.co.uk/find-an-engineer/">https://www.gassaferegister.co.uk/find-an-engineer/</a></p> | | |

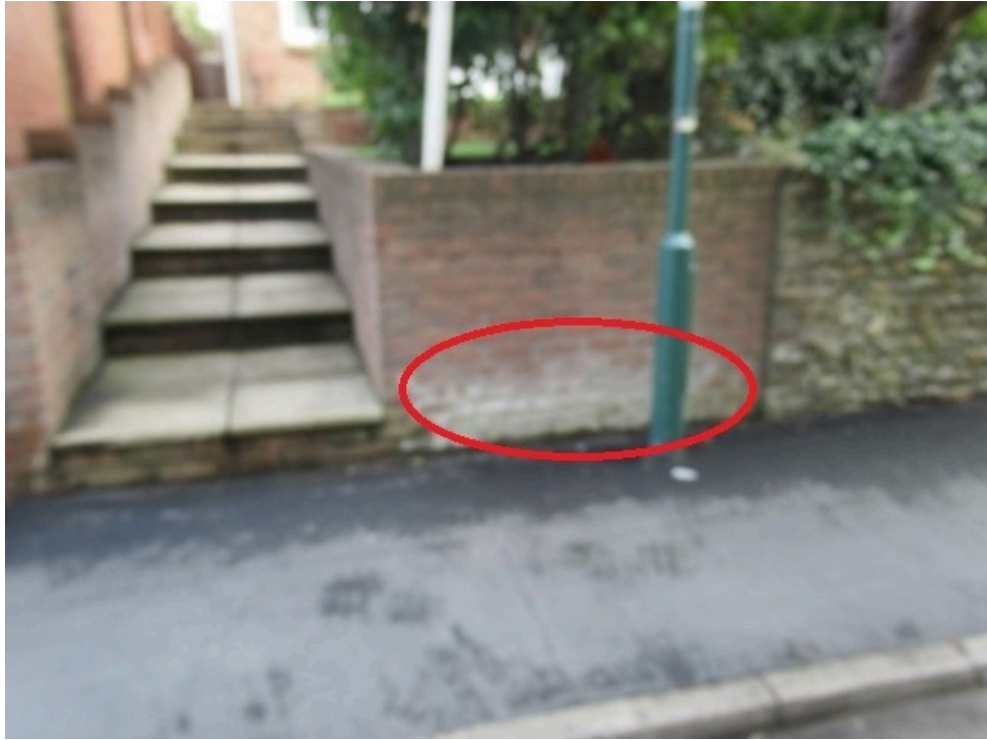
Retaining front wall has no visible drainage outlets

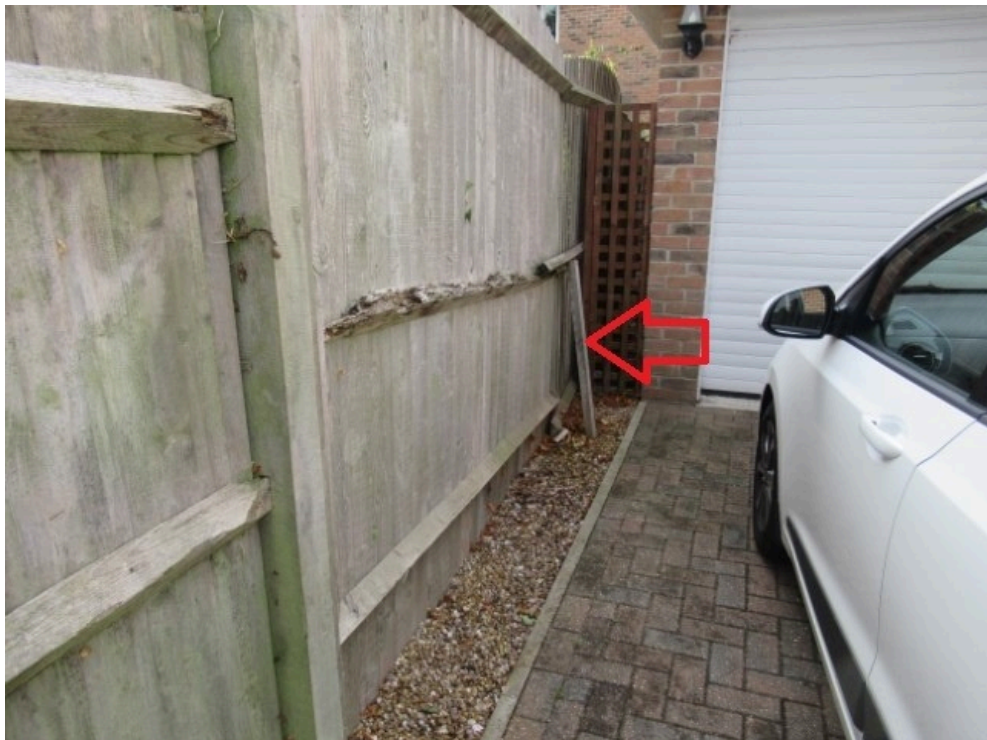
Fence adjacent to the garage is propped and worn
