## Schedule of Condition Report

**PROPERTY**            SAMPLE SURVEY  
NOT FOR DISTRIBUTION  
COPYRIGHT SKYLINE  
SURVEYORS LTD

**REF**                    SOC SAMPLE

| <b>Purpose of Survey</b> | <p>Schedule of Condition to form part of a Party Wall Award.</p> <p>The Surveyor is acting as Agreed Surveyor for works affecting 114 and 118 Acacia Road, London</p> |

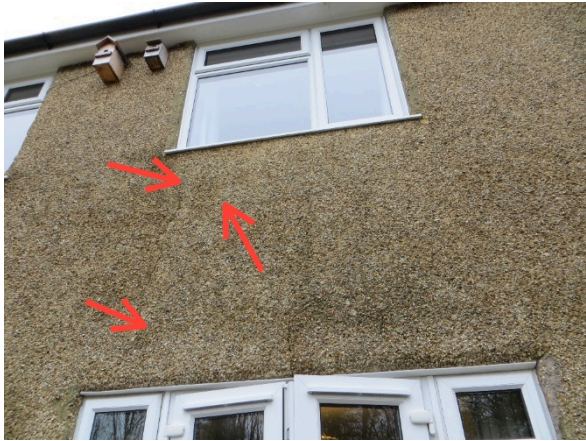
| Location / Element | Picture | Comments |
|---|---|---|
| Rear Elevation<br><br>Walls | | Cracking of the render from below the right side of the first floor bedroom window to the top of the opening of the rear French doors on the ground floor. The crack is approximately 3-4mm wide and has branch cracking to the left and right approximately 24cm below the first-floor window. |

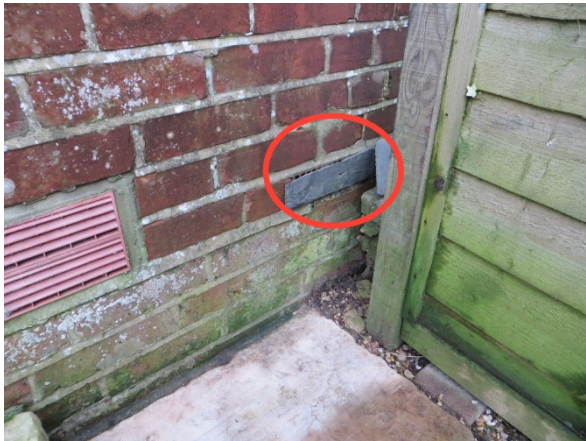
| Location / Element | Picture | Comments |
|---|---|---|
| Rear Elevation<br><br>Walls | | Displaced slate blanking plate over the airbrick that straddles the boundary line to the left side, with previous mortar repairs to the brick joints immediately above. |

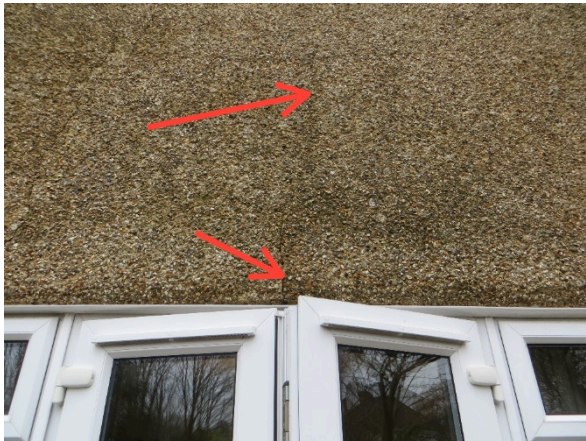
| Location / Element | Picture | Comments |
|---|---|---|
| Rear Elevation<br><br>Walls | | Cracking of the render in the central area above the rear French doors starting immediately above the doors and extending for 45cm. |

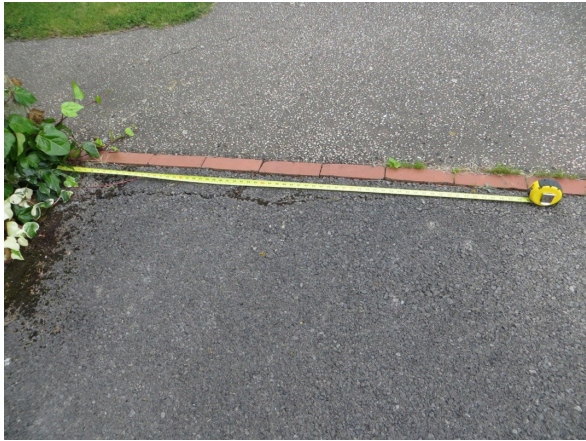
| Location / Element | Picture | Comments |
|---|---|---|
| Front of Property<br><br>Pavings and Surfaces | | Crack 1 The drive is a total of approximately 30m <sup>2</sup> and slopes down from the footpath at the front.<br>There is general age related cracking of the surface. Ther are 5 main cracks.<br>Crack 1 near to the footpath end of the drive running left to right, approximately 1.35 metres long, v-shaped to a maximum of approx 8mm width. |

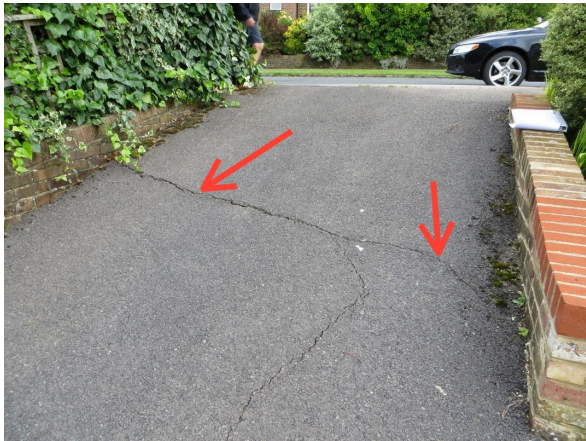
| Location / Element | Picture | Comments |
|---|---|---|
| Front of Property<br><br>Pavings and Surfaces | | Crack 2 approximately 1/3 of the distance from the footpath, across the full width of the drive from 0mm on the left side to a maximum of 25mm on the right side. |

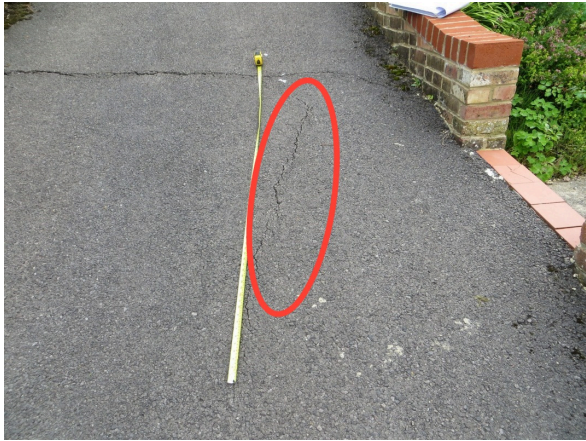
| Location / Element | Picture | Comments |
|---|---|---|
| Front of Property<br><br>Pavings and Surfaces | | Crack 3 approx mid way along the drive running front to back, approx 1.8 metres long with a jagged shape to a maximum of approx 5mm width nearest the front. |

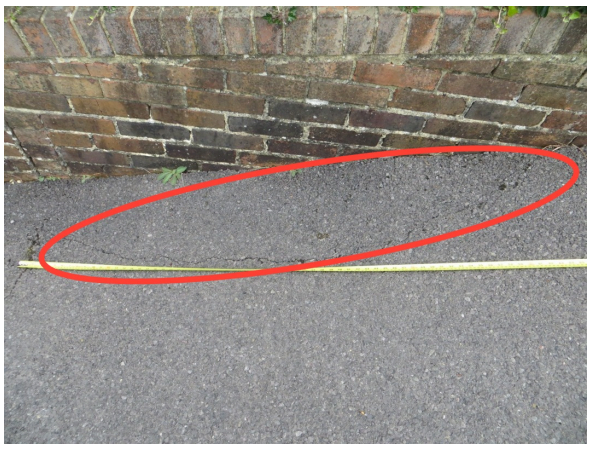
| <p>Front of Property</p> <p>Pavings and Surfaces</p> | | <p>Crack 4 is a jagged crack 1-2mm wide close to the the right side boundary wall being curved and approx 1.6 metres long.</p> |

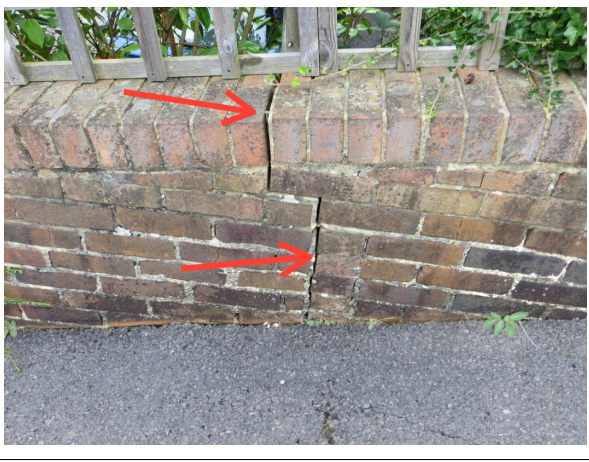
| <p>Right of Property</p> <p>Boundaries</p> | | <p>The brick dwarf wall to the right side of the drive is approximately 10.5 metres from the footpath to the garage.<br/> Approximately 5.5 metres from the footpath end there is a vertical crack in the perpend mortar joints throughout the whole height of the wall. The crack is v-shaped being approximately 2-3mm wide at the bottom, widening to 5-6mm at the top.<br/> There is a slight lateral shift of the two parts of the wall of approximately 5mm.<br/> Approximately 1 brick length away from the vertical crack 4 courses up from the base of the wall there is a single cracked brick. The crack is not extended.</p> |

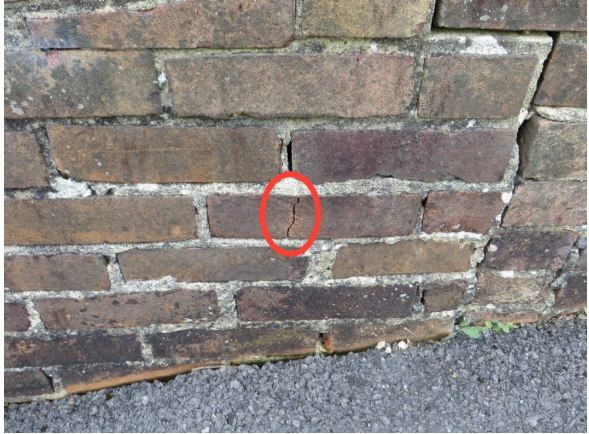
| <p>Right of Property</p> <p>Boundaries</p> | | <p>Approximately 1 brick length away from the vertical crack 4 courses up from the base of the wall there is a single cracked brick. The crack is not extended.</p> |

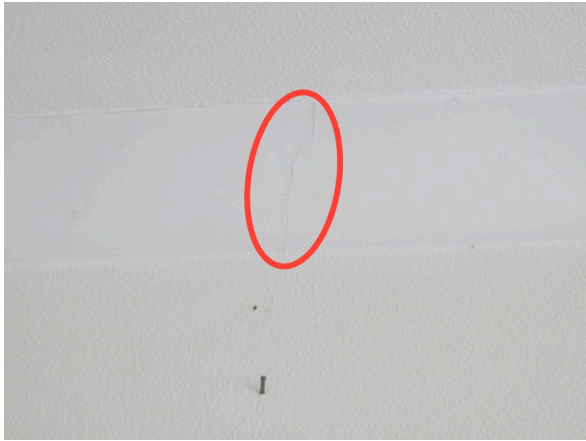
| 5 : Internal Condition | | |
|---|---|---|
| Bedroom 1<br><br>Walls | | Jagged hairline crack in the coving roughly in the centre of the chimney breast |

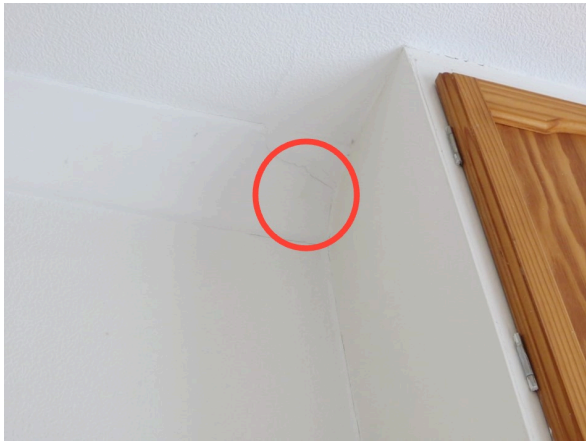
| 5 : Internal Condition | | |
|---|---|---|
| Bedroom 2<br><br>Walls | | Jagged diagonal hairline crack approx. 100mm long across the coving to the side of the rearward wardrobe. |

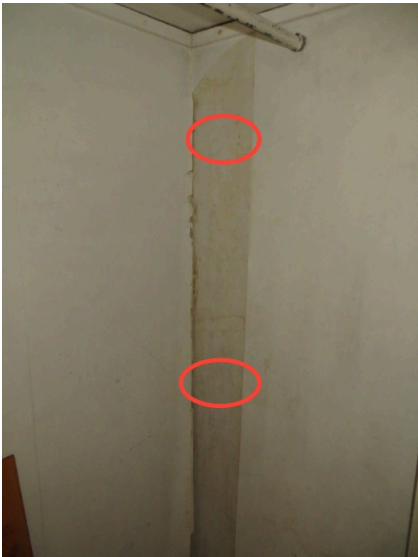
| 5 : Internal Condition | | |
|---|---|---|
| Bedroom 3<br><br>Built-In Fittings | | Jagged horizontal hairline cracking on the back wall inside the wardrobe. Two visible cracks approximately 1.0 and 1.5 metres up from floor level |

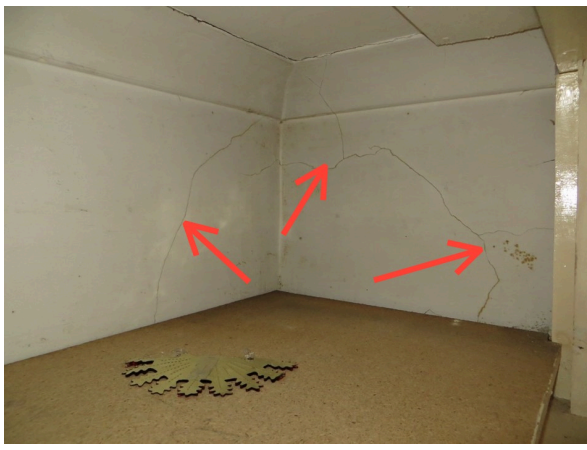
| <p>Bedroom 4</p> <p>Built-In Fittings</p> | | <p>Jagged diagonal cracking hairline to 1.5mm wide in left rear corner of upper wardrobe cupboard at approx. 45 degrees from the top left corner, and associated tributary cracks</p> |

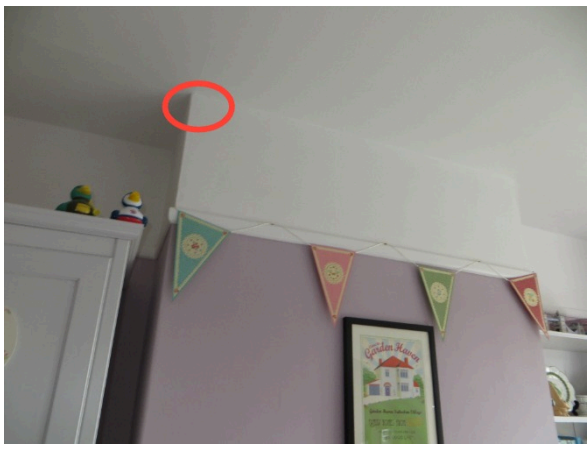
| <p>Reception 1</p> <p>Ceilings</p> | | <p>Repaired cracking across the corner of the coving on the chimney breast, approximately 1260mm forward of the rear wall. The cracking has not reopened since previous repair</p> |

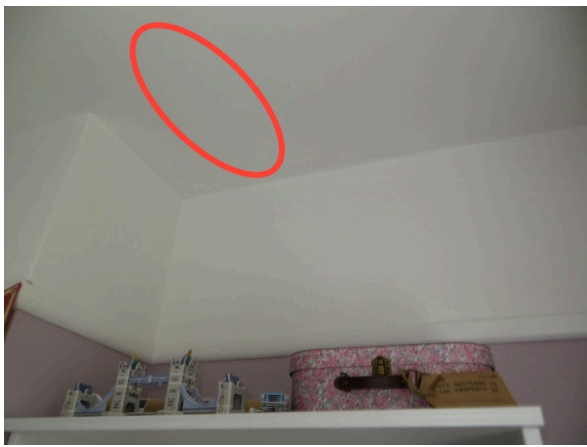
| <p>Reception 1</p> <p>Ceilings</p> | | <p>Repaired crack from the front edge of the coving on the chimney breast, diagonally rearward to the centre light fitting. The crack has not reopened since repair</p> |

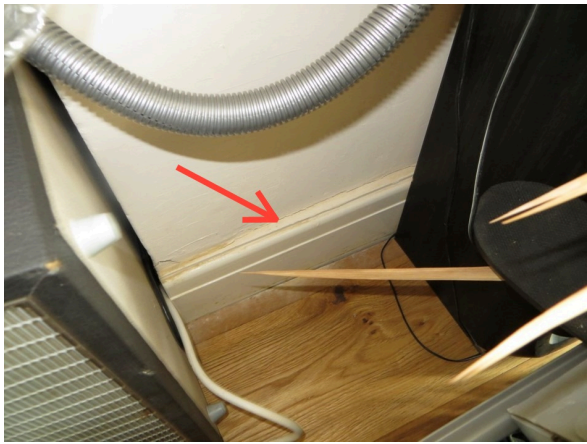
Reception 2  
Walls

Hairline cracking of the joint between the plaster and the skirting board on the front of the chimney breast. The skirting was only partially visible.
