## Defect Report - Rename as Required

**PROPERTY**                SAMPLE REPORT  
                                  SAMPLE SURVEY  
                                  NOT FOR DISTRIBUTION  
                                  COPYRIGHT SKYLINE  
                                  SURVEYORS LTD

**SURVEY DATE** 1 Oct 2025

**REF**                        SDEF SAMPLE

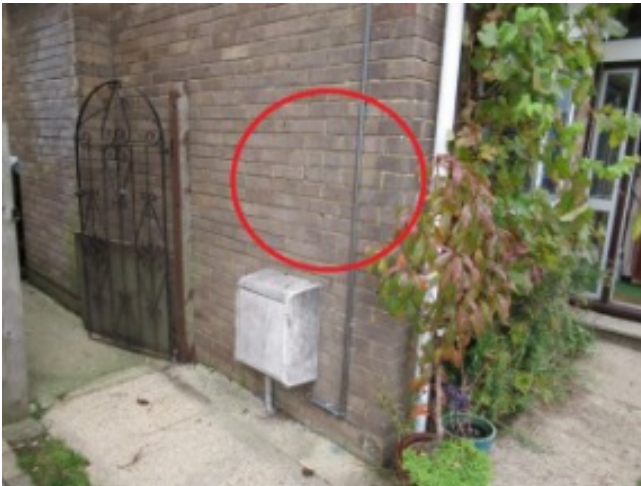
3. External wall adjacent to the dining room

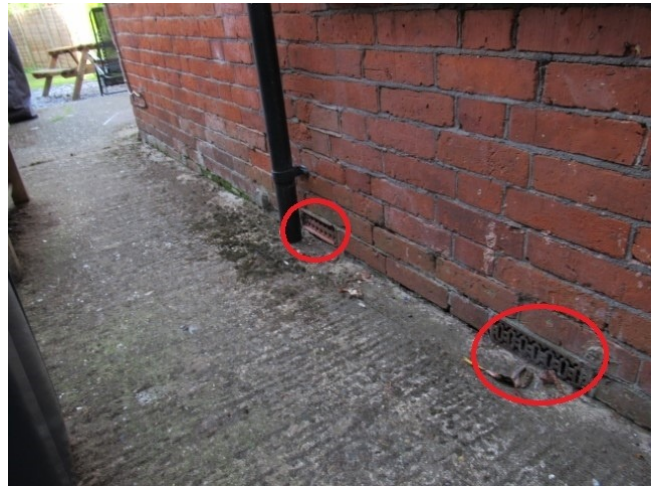
4. External face of area where damp detected

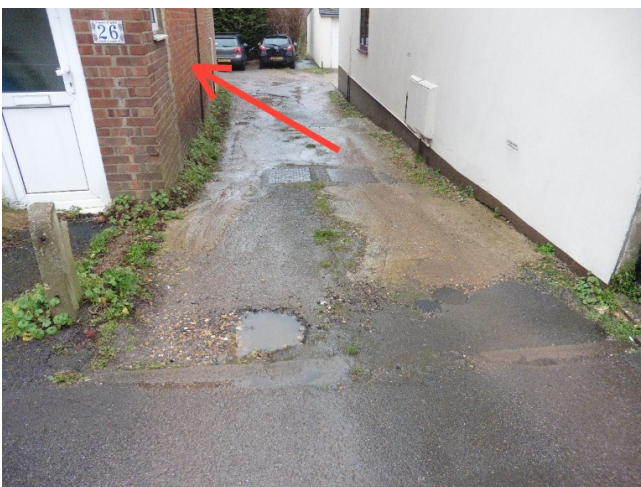
| <b>Conclusion</b> | <p>It was noted that a water supply pipe to the external tap on the outside wall of the dining room is likely to be embedded in the floor of the dining room.</p> <p>The very localised nature of the dampness being experienced suggests that because is not a failure of the damp proof course, but more likely to be a leak from the water supply pipe which runs under the wall immediately beneath the area where dampness is being experienced.</p> |

5. Location of external tap

| <b>Recommended actions</b> | <p>The floor of the dining room in the area between the external tap and the kitchen will need to be carefully excavated to reveal the water supply pipe believed to be concealed beneath. The assumed leak should be identified and repaired as necessary.</p> |

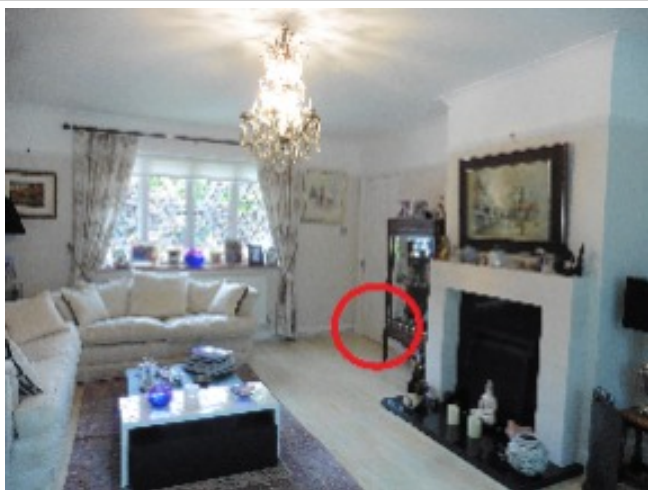
7. Area where damp was detected

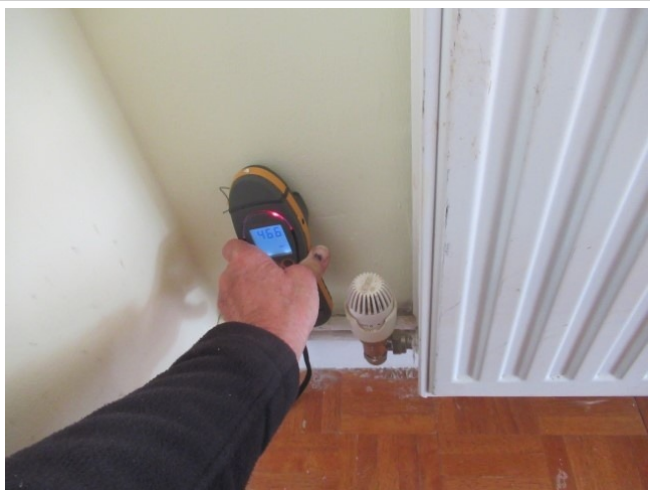
8. High internal moisture readings

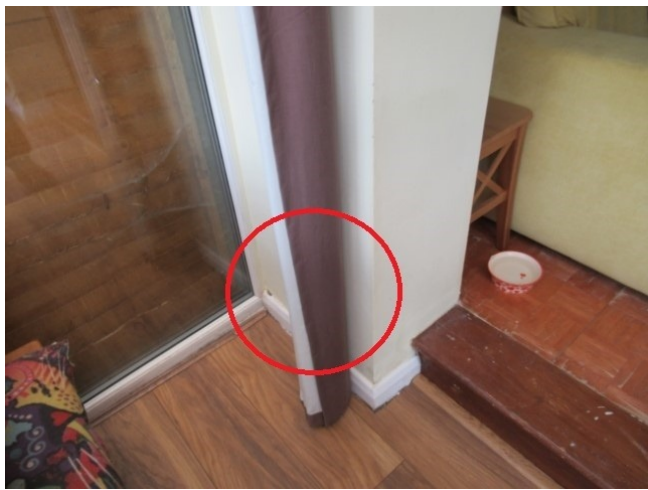
9. Wall staining in the dining room

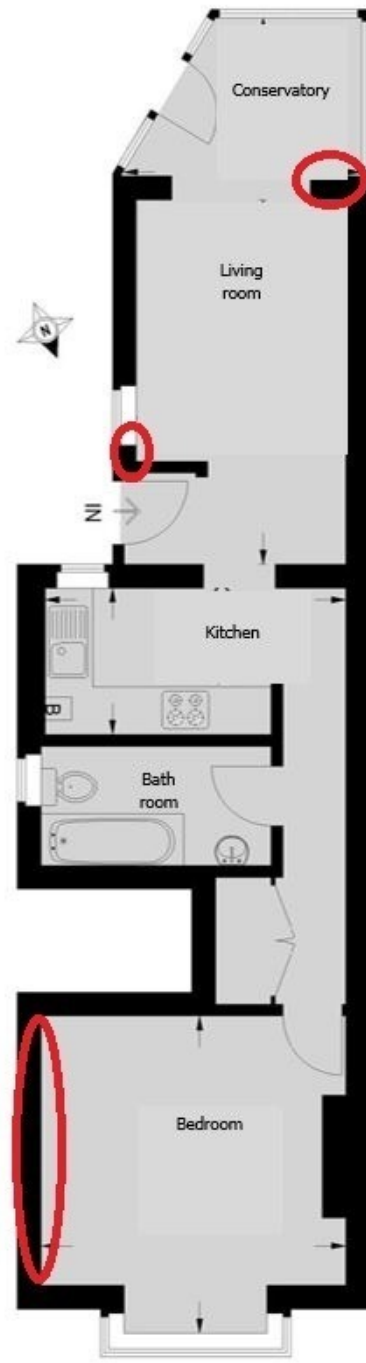
1. Areas where dampness was recorded
