# BUILDING SURVEY REPORT

**PROPERTY**            SAMPLE SURVEY  
NOT FOR DISTRIBUTION  
COPYRIGHT SKYLINE  
SURVEYORS LTD

**SURVEY DATE** 1 Oct 2025

**REF**                    BS SAMPLE

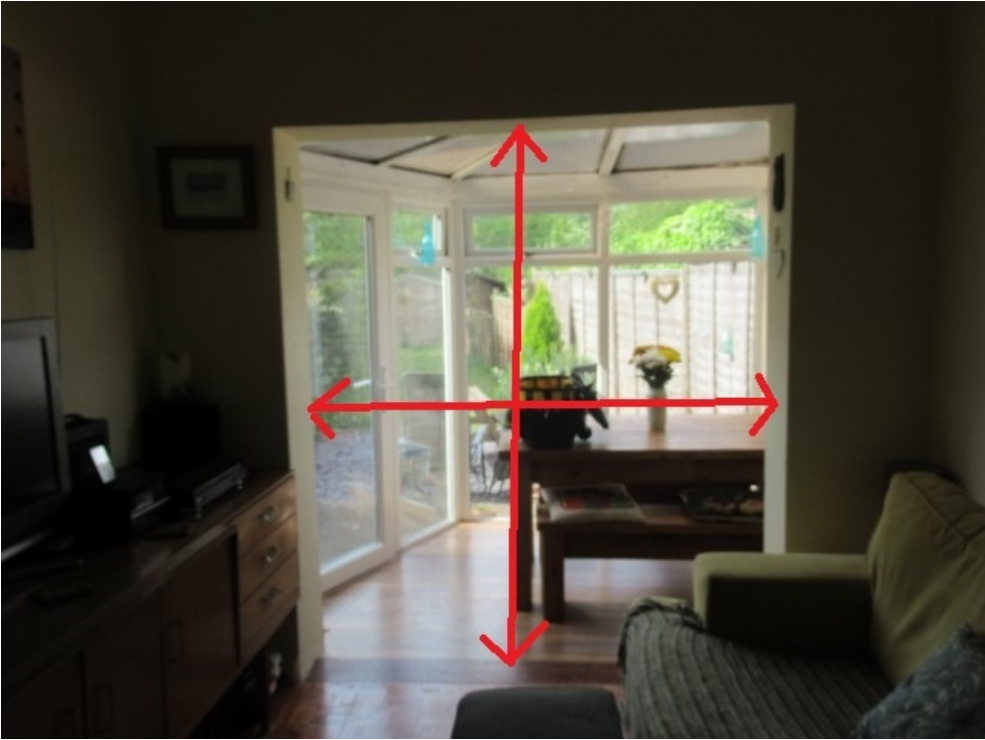
| <div>Extensions<br/>&amp;<br/>Alterations</div> | <div>Extensions: None noted</div> <div>Conservatory: A conservatory has been added to the rear of the property. As it opens directly into the living area, and is heated form the main heating system, building regulations approval may have been required.</div> <div>Loft Conversion: None noted</div> <div>New Boiler: A modern condensing boiler has been installed</div> <div>Chimney / Breast Removals: None noted</div> <div>Wall Removal: an internal wall has been removed between the house and conservatory.</div> <div>Post 2002 Windows: None noted</div> <div>Log Burner Installation: None noted</div> <div>Electrical Circuits: None noted</div> <div>Renewables: None noted</div> <div>Drainage: None Noted</div> <div data-bbox="394 1019 1383 1756"></div> <div>Wall between house and conservatory removed</div> |

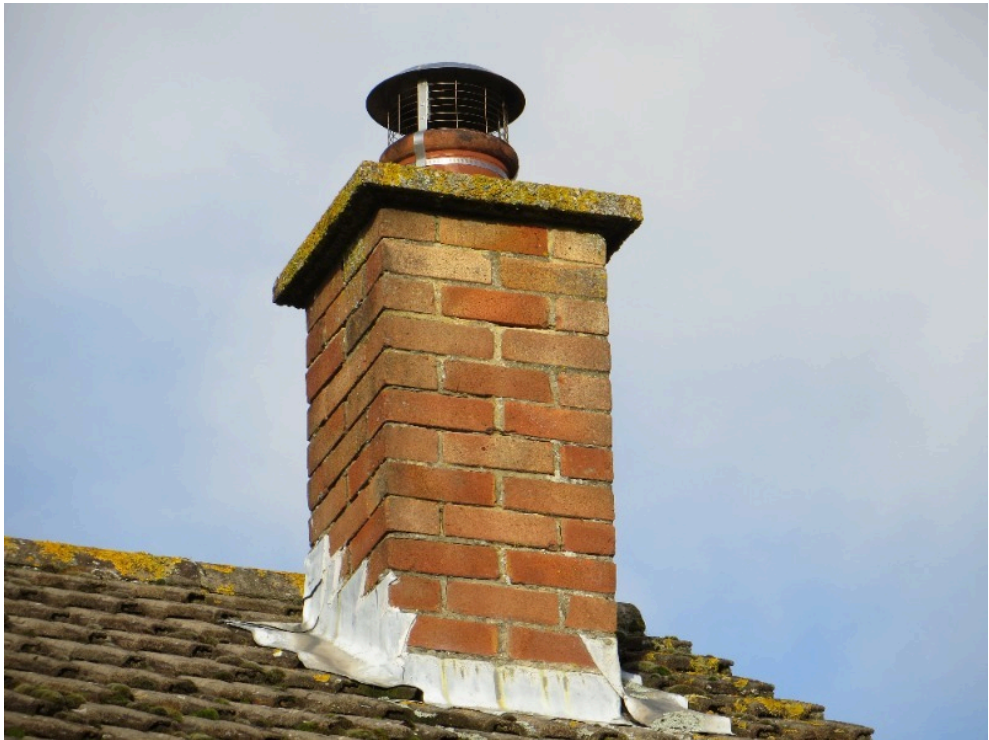
Stack to the right side

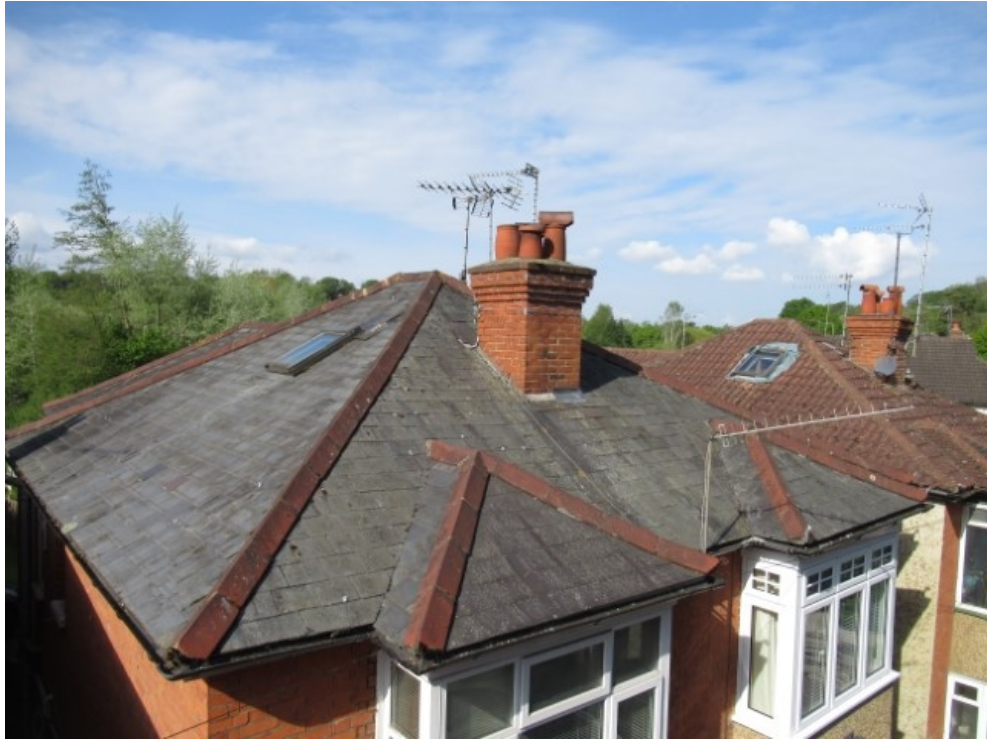
| COMPANY<br>THUMBNAIL<br>HERE | 4.2 Roof Coverings | Condition<br>rating | 3 |
|---|---|---|---|
| <b>Condition</b> | <p>No evidence was seen of unusual sagging or other movement which might indicate that the structure is failing.</p> <p>However, the roof covering, which is probably the one installed when the house was originally built, is very worn and close to the end of its normal expected service life.</p> <p>The presence of a large number of tingles, which are used to replace slates which have slipped due to failure of the nails holding them, suggests that many of the nails are now corroded and likely to fail in the near future. There are tingles and slipped slates present on all of the roof pitches.</p> | | |

View of front roof using pole camera

| COMPANY<br>THUMBNAIL<br>HERE | 4.2 Roof Coverings | Condition<br>rating | 3 |
|---|---|---|---|
| <b>Action Required</b> | <p>Slate roofs have a lifespan of around 100 years and so it should not be unexpected that this roof is now close to the end of its expected service life.</p> <p>It is likely, therefore, that the entire roof will need replacing in the near future and that this work will be at the significant cost. You should budget accordingly.</p> <p>Whilst it is possible to continue replacing slipped slates, the number that have already been replaced is clear evidence that the roof is due for replacement.</p> | | |

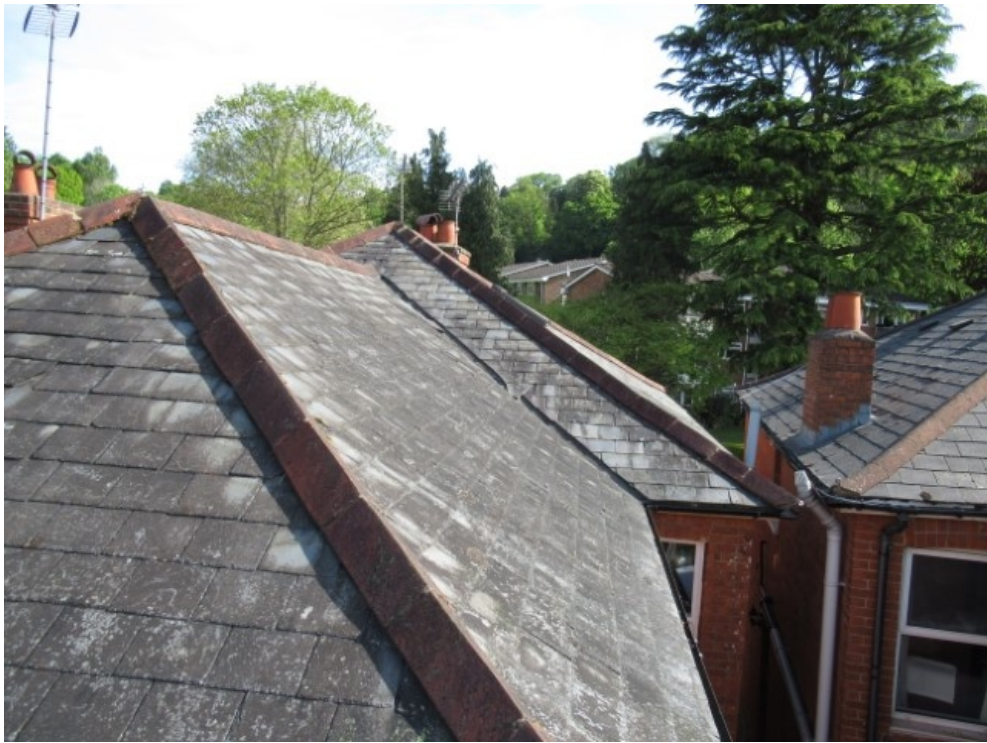
View of rear addition roof

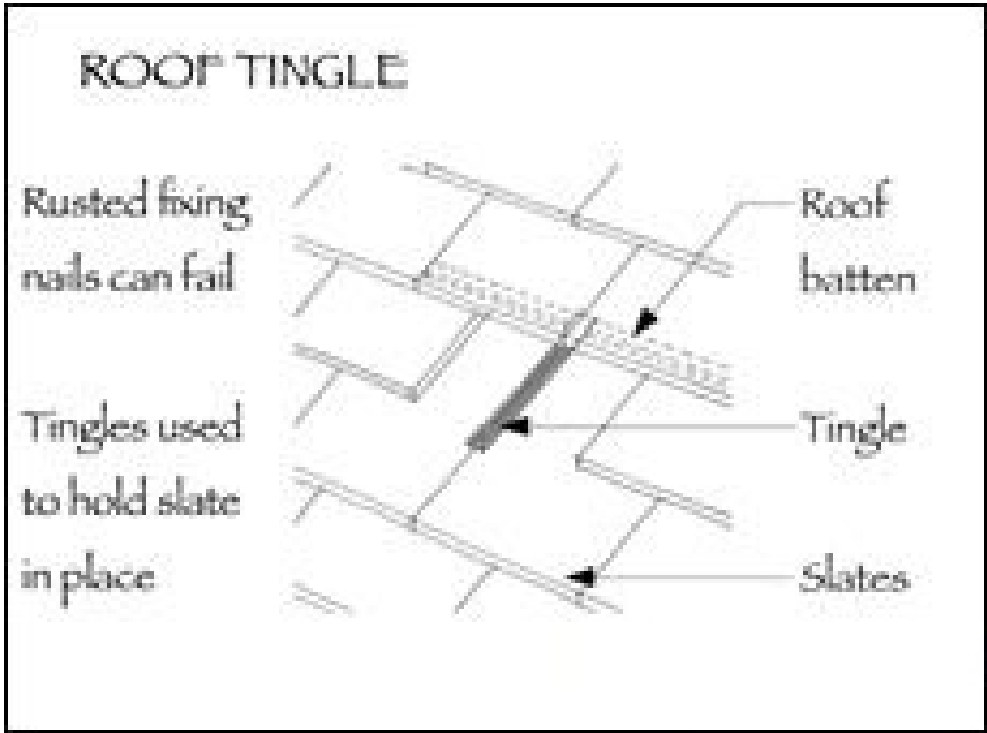
Tingle

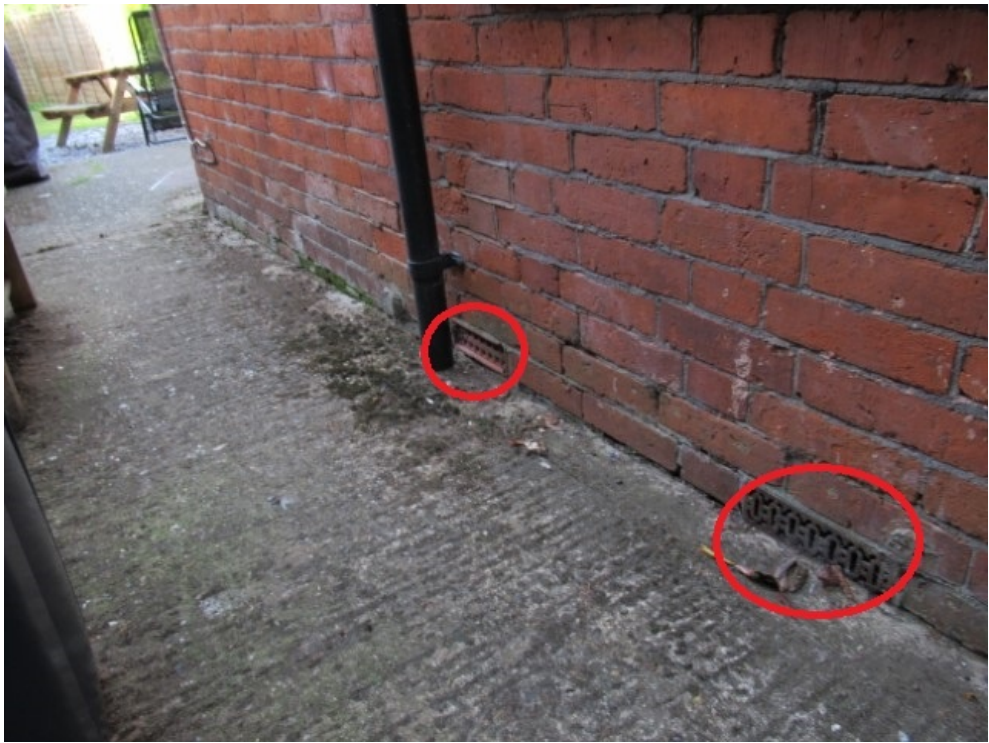
Air bricks on the left side wall

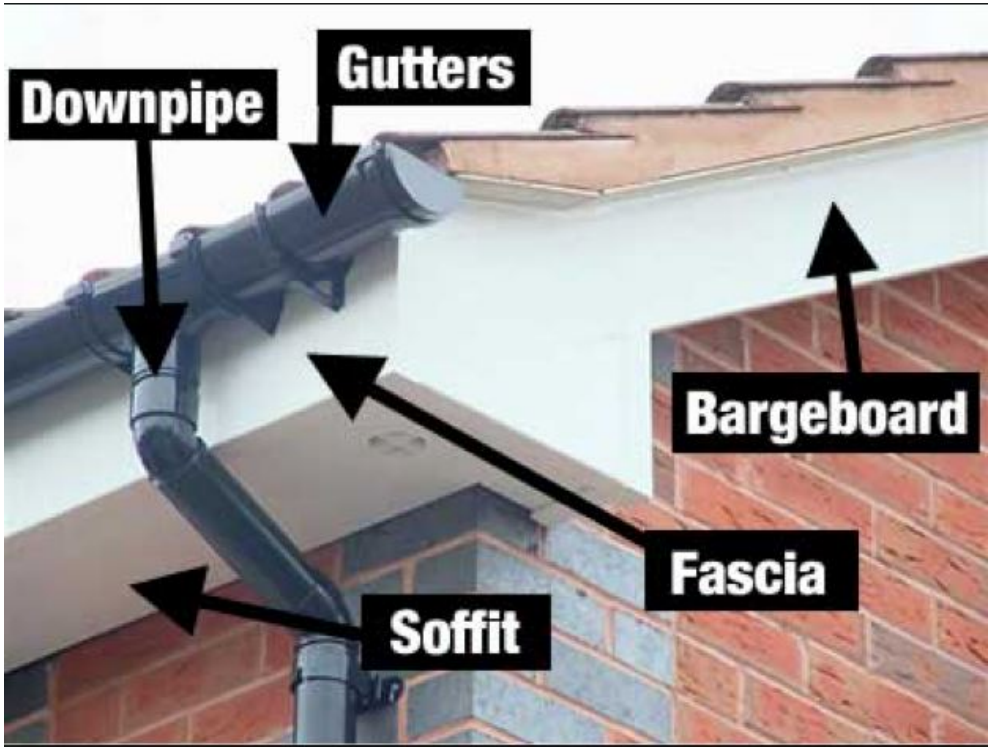
Eaves detail

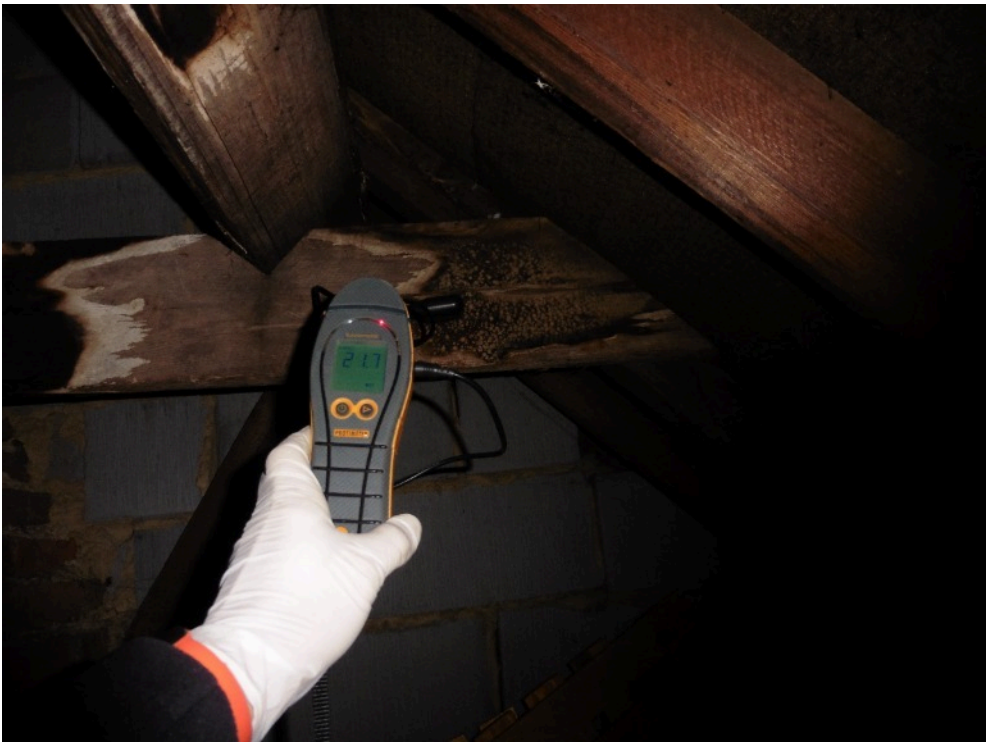
Normal moisture readings recorded

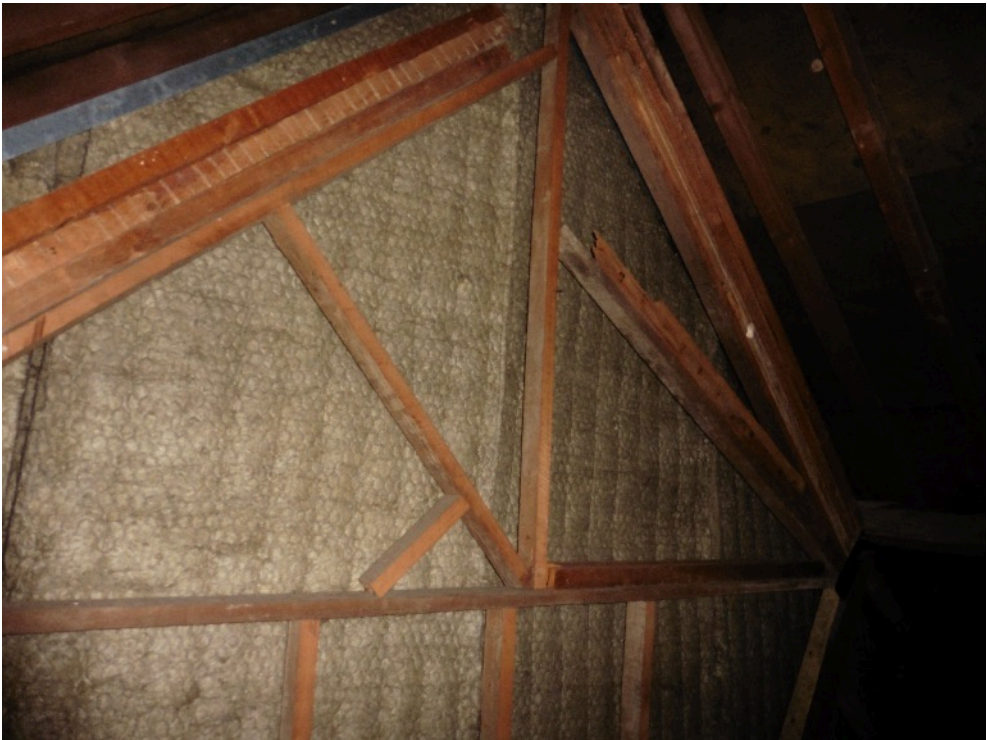
Fibrous material forming fire wall

| <b>Action Required</b> | <p>Make enquiries to determine the nature of the fire resistant barrier installed to the left side as there is no indication of whether this is a suitable or acceptable installation. This is considered to be an urgent and important matter.</p> <p>No specific repairs are required other than to try and include some additional ventilation within the roof space, perhaps by way of roof tile vents. This would help to manage moisture levels within the roof more efficiently. It is important to ensure that spaces remain well ventilated so as to reduce the likelihood of the development of defects such as rot and infestations by wood boring insects.</p> <p>If installing extractor fans, make sure that hoses passing through the roof space extend to an external grille so that warm moist air is not ventilated into the roof.</p> <p>Care should be taken when moving around, or storing heavy objects, in the roof space. The spaces between the floor joists will not support a person's weight, or that of large boxes etc. Floor boarding should be properly secured and fixed.</p> <p>Although no evidence was seen to indicate that the steel beams visible within the roof space are the cause of any defect or concern, it would be prudent to carry out a more detailed inspection, including removal of the floor boarding, to understand why the beams are present and what function they provide.</p> |

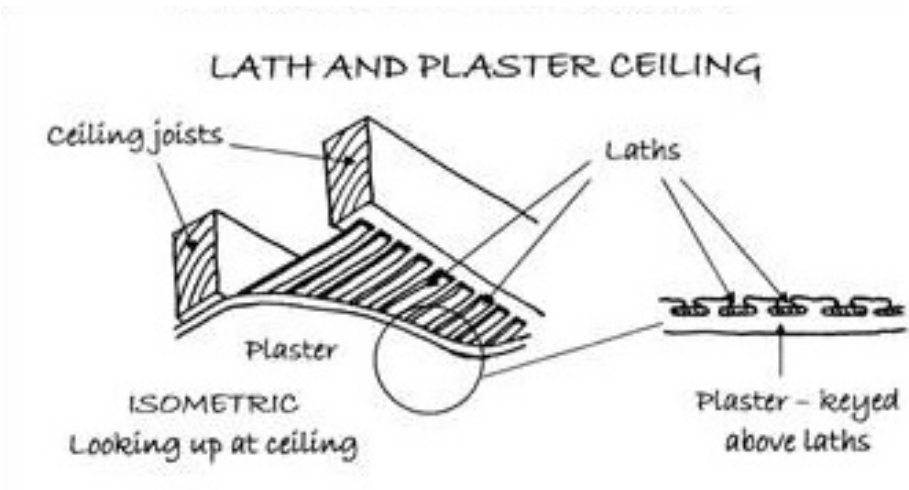
Lath and plaster ceiling

| COMPANY<br>THUMBNAIL<br>HERE | 5.2 Ceilings | Condition<br>rating | 1 |
|---|---|---|---|
| <b>Action<br/>Required</b> | <p>Normal maintenance is required, including filling and redecorating cracks as necessary.</p> <p>Lath and plaster ceilings which have remained in place for many years may become unstable over the course of time as the plaster loses its key to the laths. Often it is difficult to identify such instability without performing destructive checks to assess the security of the surface of the ceiling. Whilst it is not possible to carry out these checks during the course of a visual survey, it is recommended that you assess the stability of the ceilings by checking them for areas of loose surface plaster, or undue movement when pressed.</p> | | |

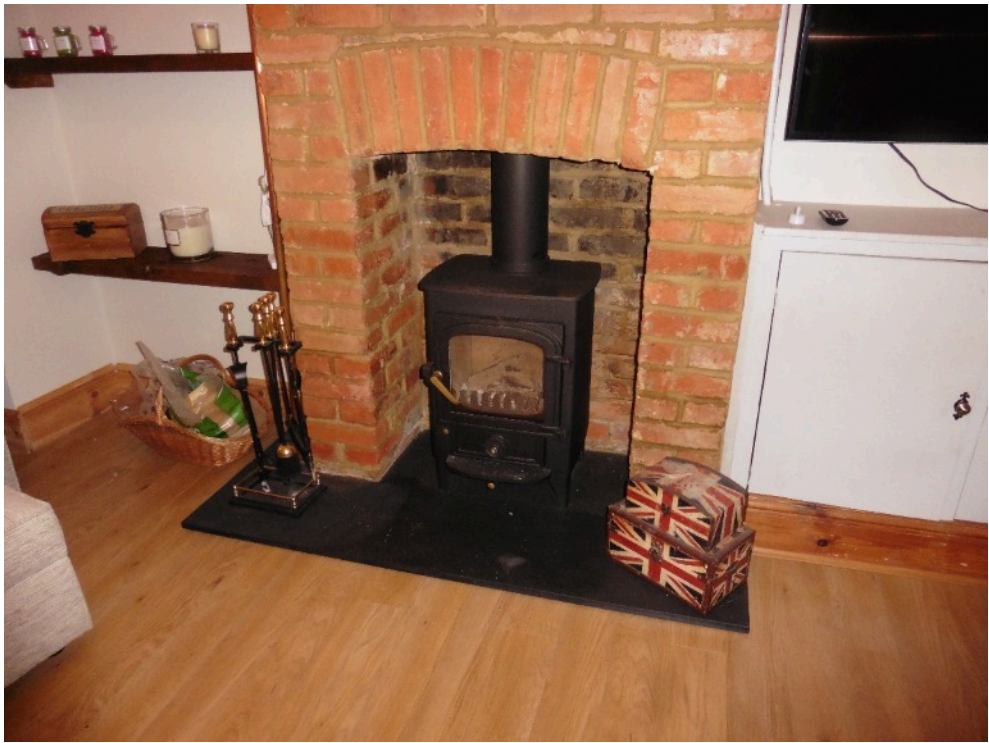
Stove in the living room

| COMPANY<br>THUMBNAIL<br>HERE | 5.5 Chimney Breasts, Fireplaces and Flues | Condition<br>rating | 1 |
|---|---|---|---|
| <b>Action<br/>Required</b> | <p>It is important to maintain an adequate airflow, by means of ventilation, through unused chimney flues to prevent the build-up of condensation within the chimney.<br/>Flues should be checked by a reputable heating engineer specialising in flues and chimneys, prior to use.</p> | | |

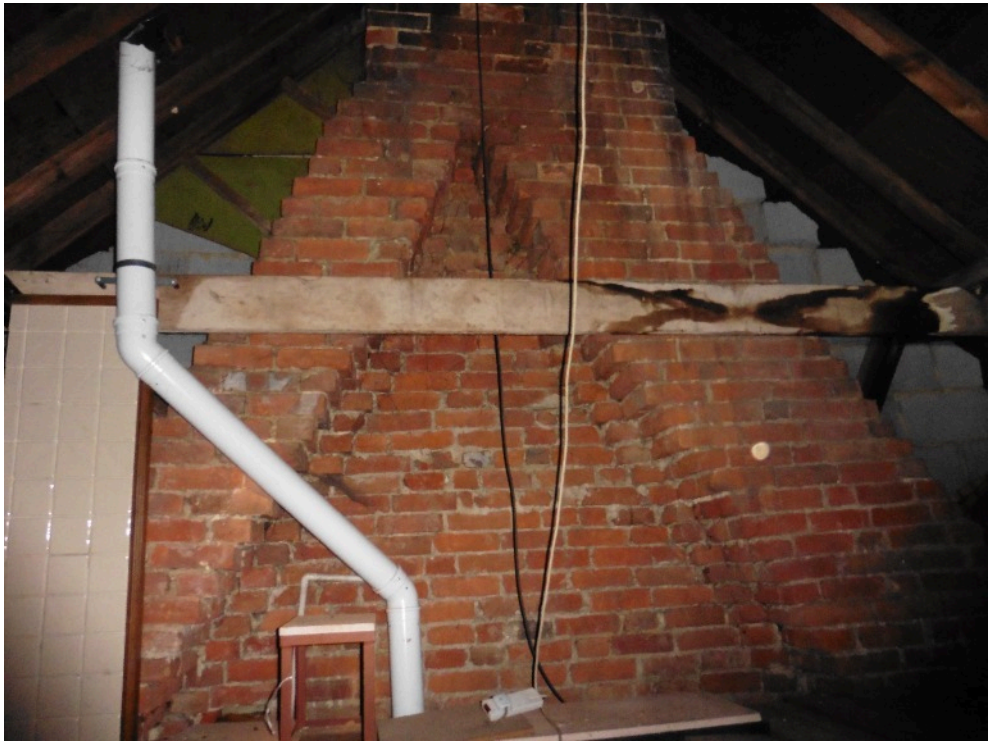
Front and rear chimney breasts in the roof space

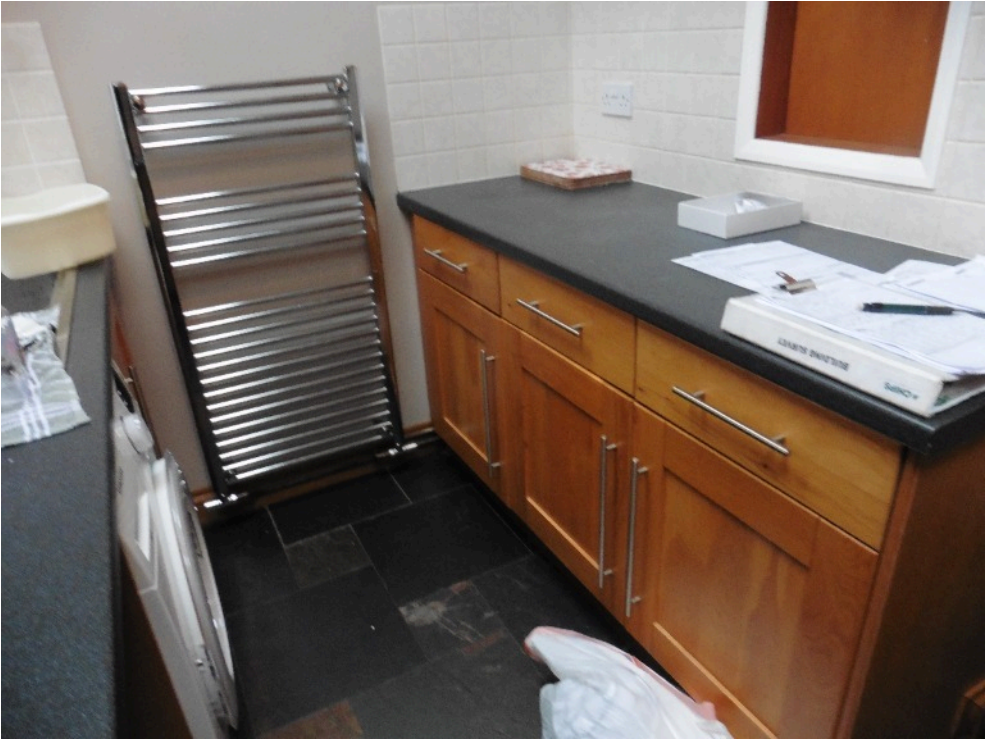
| COMPANY<br>THUMBNAIL<br>HERE | 5.6 Built-In Fittings | Condition<br>rating | 1 |
|---|---|---|---|
| Condition | The fittings are of a basic style and in a serviceable condition.<br>The flow of water at the sink was found to be within a normal range and considered to be suitable for the intended use.<br>Hot water was obtained from the hot tap.<br>It was noted, though, that the mixer tap unit is loose and requires re-fixing. | | |

| COMPANY<br>THUMBNAIL<br>HERE | 5.6 Built-In Fittings | Condition<br>rating | 1 |
|---|---|---|---|
| Action<br>Required | Maintain, repair or replace units as necessary. | | |

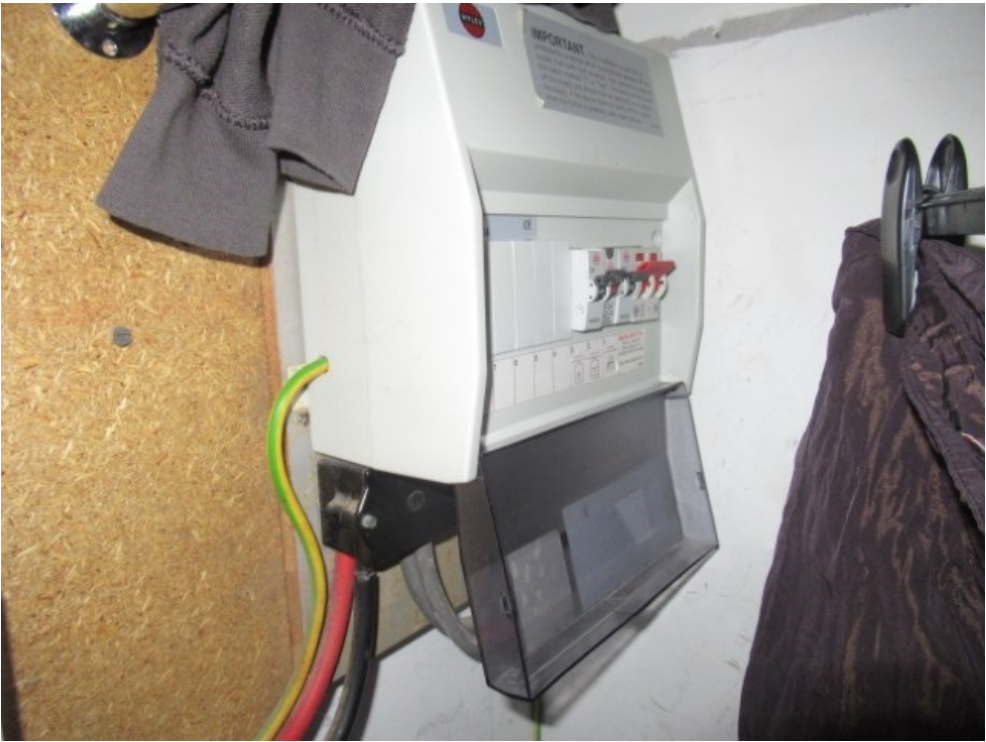
| COMPANY<br>THUMBNAIL<br>HERE | 6.1 Electricity | Condition<br>rating | HS |
|---|---|---|---|
| <b>Condition</b> | <p>No evidence of broken, loose or damaged parts of the installation was seen, nor were any obvious amateur alterations or interventions noted. However, where furniture and other items are present many of the outlets can be hidden from view.<br/> As far as could be seen the visible wiring is of a modern PVC type.<br/> A label on the consumer unit suggest that the installation was last inspected in 2013.</p> <p>The number of socket outlets in each room was not visible, but extension leads visible suggests that there may be insufficient outlets for modern needs. You may wish to have further sockets added. This work should be carried out only by a qualified electrician.</p> | | |

| <p><b>Action Required</b></p> | <p>NAPIT recommends that domestic electrical installations are inspected and tested every 10 years in line with IET (The Institution of Engineering &amp; Technology) Guidance Note 3 covering Electrical Installation Condition Reports (EICR). This guidance also recommends that at any change of occupancy (such as a house sale, or change of tenant) an Electrical Installation Condition Report is carried out to prove the installation to be in a satisfactory or unsatisfactory condition. This report should cover all the fixed wiring and equipment within the property boundaries, including outbuildings.</p> <p>You can get further information from the Electricity Safety First at <a href="http://www.electricalsafetyfirst.org.uk/guides-and-advice/around-the-home/how-safe-is-your-home/">http://www.electricalsafetyfirst.org.uk/guides-and-advice/around-the-home/how-safe-is-your-home/</a></p> <p>Any electrical works carried out should have been completed by a Registered Competent Person (Electrical) and, as such, would have provided a Minor Electrical Installation Works Certificate, or an Electrical Installation Certificate, and in addition a Building Regulation Compliance Certificate where required.</p> <p>At the time of the survey no documentation was seen to verify that an inspection has been carried out within the last 10 years and the installation must therefore be considered to be in a potentially dangerous and unsatisfactory condition. An electrical installation can look to be in a safe condition, but serious defects may be hidden within the walls or under floors. It is therefore considered to be essential that you commission an inspection and testing of the electrical installation prior to purchase of the property, unless you are provided with verifiable evidence that such an inspection has recently been carried out by a registered competent person (electrical.)</p> <p>There is no legal requirement on the seller of a house to provide an up-to-date Electrical Installation Condition Report. Whilst it is not unreasonable to ask the seller to provide evidence of the condition of the electrical installation, they are under no obligation to do so.</p> |

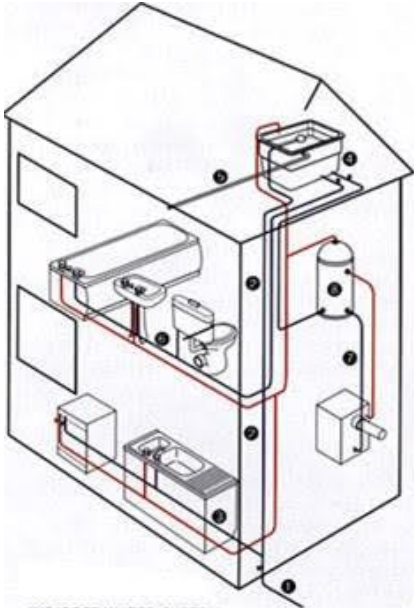
| COMPANY<br>THUMBNAIL<br>HERE | 6.3 Water | Condition<br>rating | 1 |
|---|---|---|---|
| | <p>Indirect DHW system</p> | | |

| COMPANY<br>THUMBNAIL<br>HERE | 6.3 Water | Condition<br>rating | 1 |
|---|---|---|---|
| Condition | No significant defects were noted.<br>The flow of water at all outlets checked was found to be within a normal range. Hot water was obtained from all hot tap outlets. | | |

| COMPANY<br>THUMBNAIL<br>HERE | 6.3 Water | Condition<br>rating | 1 |
|---|---|---|---|
| Action<br>Required | Check the installation for evidence of leaks or other defects on a regular basis i.e. approximately every 6 months, or sooner. Leaks most often occur at pipe joints and where pipes are subject to movement or physical damage, such as airing cupboards, roof spaces and under sinks. | | |

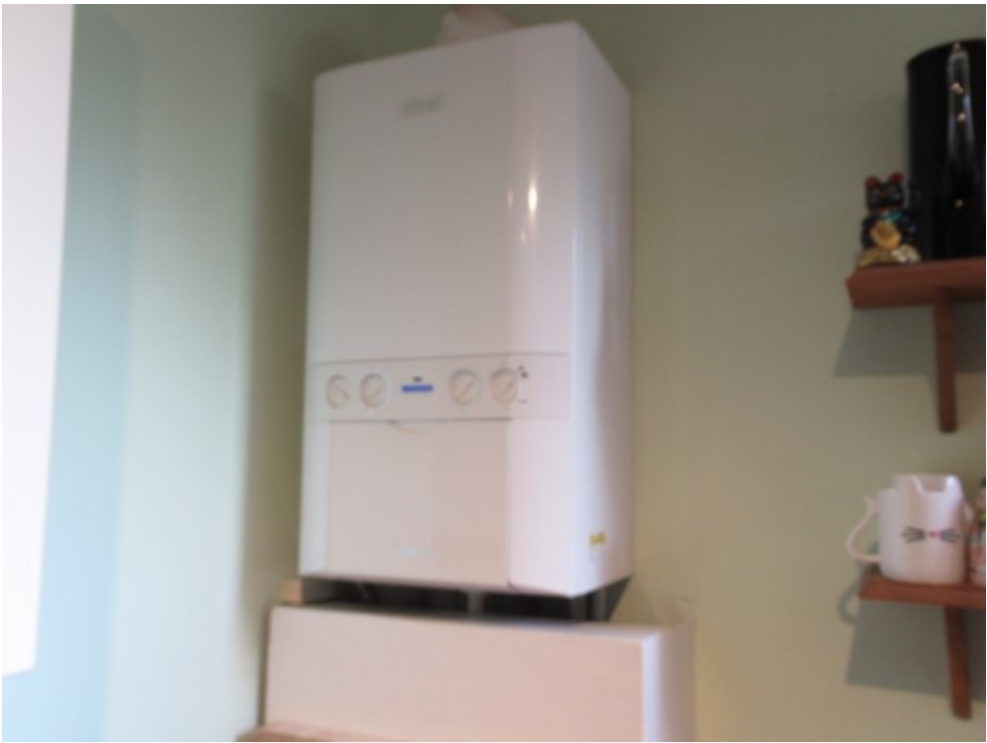
Boiler

| COMPANY<br>THUMBNAIL<br>HERE | 6.4 Heating and Cooling | Condition<br>rating | HS |
|---|---|---|---|
| <b>Condition</b> | <p>No documentary evidence was available to suggest that the boiler has been recently serviced. Under normal circumstances a modern boiler will last for 15-20 years before requiring replacement. It is believed that the boiler is between 3 and 10 years old and so may be around halfway through its normal expected service life.</p> | | |

| COMPANY<br>THUMBNAIL<br>HERE | 6.4 Heating and Cooling | Condition<br>rating | HS |
|---|---|---|---|
| <b>Action<br/>Required</b> | <p>Gas Safe recommends that all gas appliances and boilers are inspected and serviced according to manufacturer's guidance, but at least once a year. A gas installation can look to be in a safe condition, but serious defects may be hidden, some of which can kill. It is therefore considered to be essential that you commission an inspection of the gas/heating installation prior to purchase of the property, unless you are provided with verifiable evidence that such an inspection has recently been carried out by a competent person.</p> <p>You can get more information, or find a Gas Safe registered engineer <a href="https://www.gassaferegister.co.uk/find-an-engineer/">https://www.gassaferegister.co.uk/find-an-engineer/</a></p> | | |

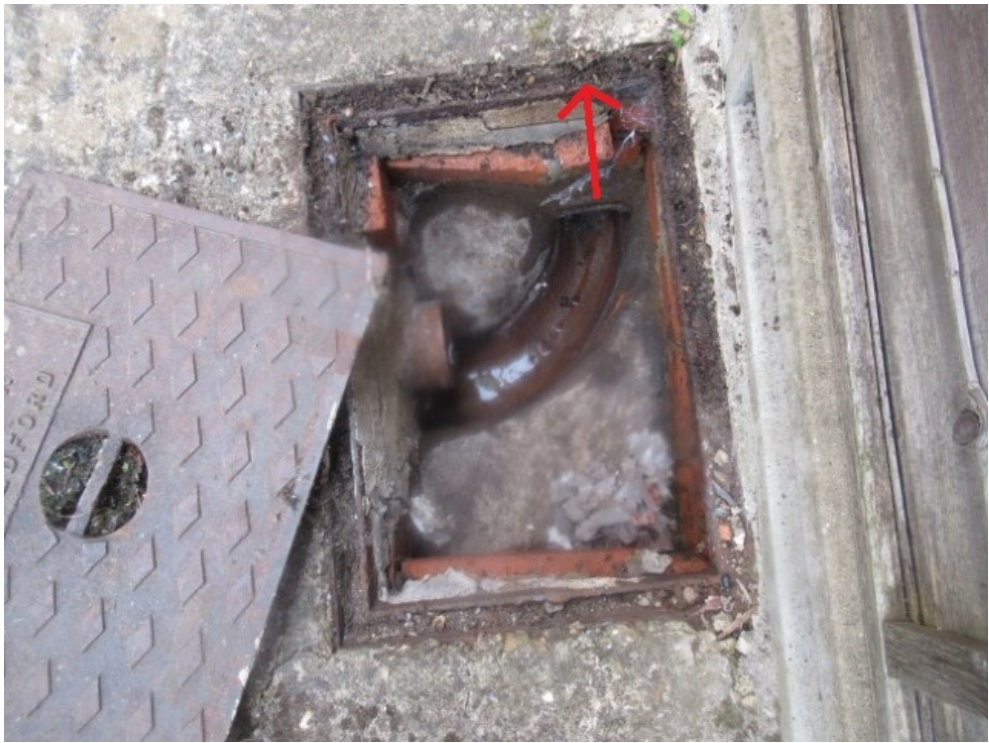
| COMPANY<br>THUMBNAIL<br>HERE | 6.5 Drainage | Condition<br>rating | 1 |
|---|---|---|---|
| <b>Condition</b> | <p>Water was seen to run through the chamber with no blockages or undue levels of silt being apparent.</p> <p>It should be noted that the internal drainage network was not inspected with the use of cameras and therefore no assessment could be made of the condition of the drains other than at the inspection chambers described above.</p> <p>The soil vent pipe at the rear of the house is likely to be made of a material that contains asbestos.</p> <p>In its current condition it presents no risk to health with any asbestos fibres being fully and securely encapsulated within the material of the pipe. Care and advice should be taken before any attempt to remove it. See section 3.4.</p> | | |

Inspection chamber to the left side rear with the house to the left of the picture

| <b>Action<br/>Required</b> | <p>Drains should be regularly inspected to ensure they remain free from blockages, tree root damage or other obstructions.</p> <p>It is often suggested that the manholes only allow inspection of 5-10% of an entire drainage installation. As such, it is entirely possible that damage can be present within the system but which would not be apparent from opening the manholes.</p> <p>The only way to confirm the condition of the whole installation is to commission a CCTV inspection from a qualified contractor, for example a member of the National Association of Drainage Contractors at <a href="http://www.nadc.org.uk/">www.nadc.org.uk/</a></p> |

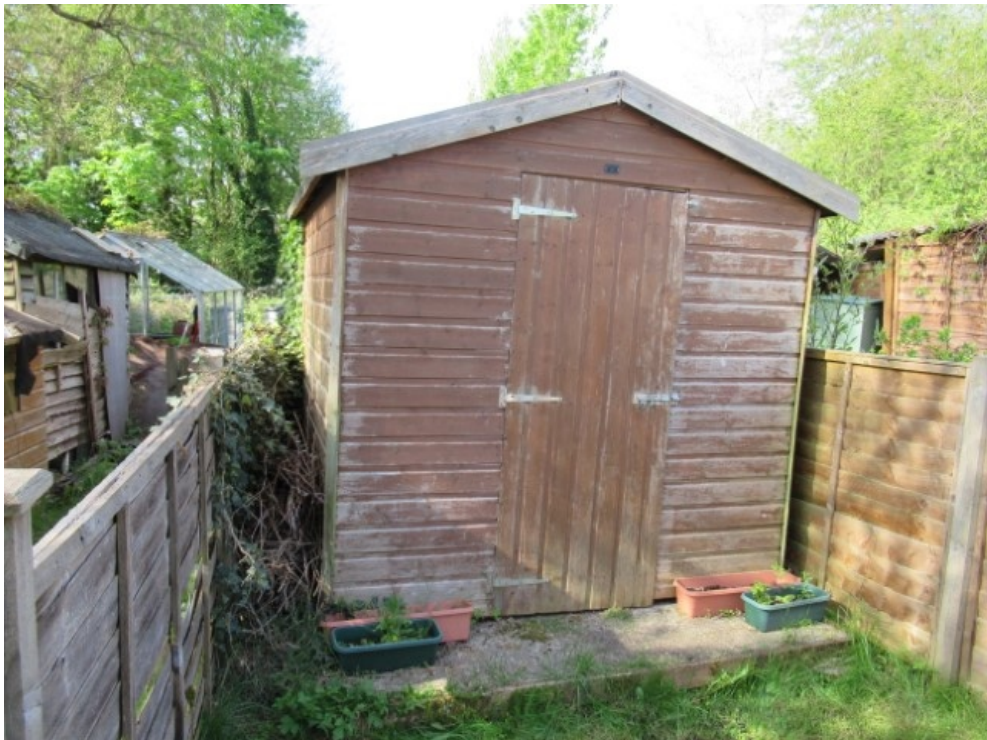
Shed

| Condition | The outer walls of the shed have not been maintained in recent years and require re-treatment.<br>The roof covering does not show evidence of leaks, but is obviously quite worn.<br>Overall, though, the shed was found to be in an average condition. | | |

| Action<br>Required | Normal maintenance, including regular retreatment of the walls, is required.<br>Foliage and debris should be removed from the outside walls.<br>Compared to traditional coverings such as tiles and slates, most felt roofs have a typical life of 10-25 years. They are also prone to sudden failure and leakage. Periodic re-covering will therefore be necessary. When this is undertaken, the supporting structure may also need some attention. | | |

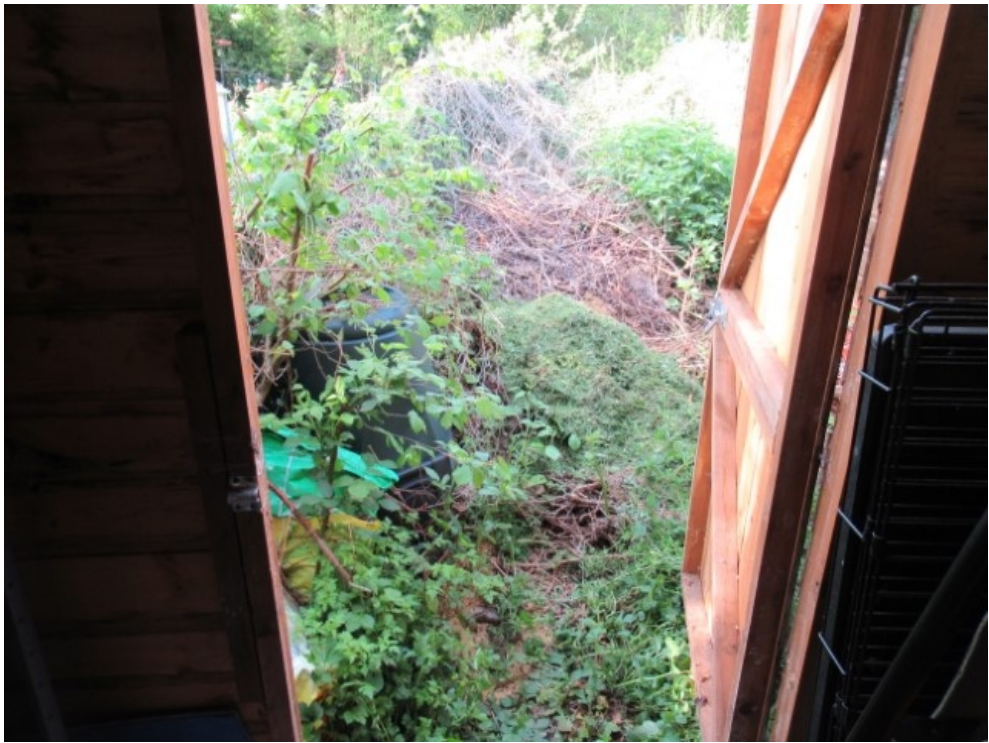
Rear door opens to remainder of garden area
