# Landlords Decent & Safe Home Review

FORMING PART OF SURVEY REPORT REF BTL SAMPLE

**PROPERTY** SAMPLE SURVEY

**SURVEY DATE** 1 Oct 2025

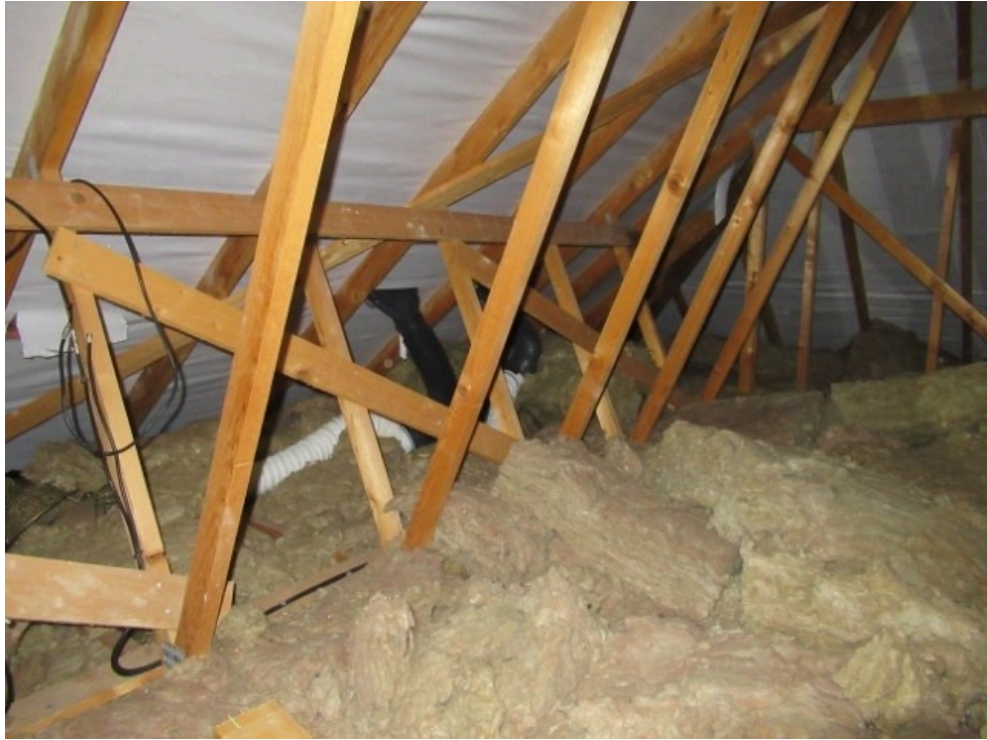
Looking towards the left rear

| <b>Condition</b> | <p>No significant defects were noted during my inspection and the roof was found to be structurally sound.</p> <p>No evidence was seen of any unusual movement or stress of the supporting timbers within the roof, and there have been no obvious significant alterations to the structure which might have resulted in it becoming substantially weakened.</p> <p>Trussed rafter roofs are constructed from sections made off-site which are raised into position and fixed during construction of a property. They are constructed from timbers joined by steel plates to a design based on the shape of the roof and the loads imposed by the weight of the roof covering.</p> <p>It is important that the timbers of the roof trusses are not cut, notched or separated as this will significantly weaken the roof structure. They should not be overloaded by storage of heavy objects in the roof space, and the weight of any light items being stored should be well distributed using fixed boards.</p> <p>Between the outer tile covering and the inner timbers is an underlining, sometimes called "sarking". It is present to provide an additional weather-proofing layer to moisture, snow and rain etc. that may be blown past the outer covering. In older properties it may not be present at all. Typically, in the 1920's the sarking is of timber planks. Later properties often have a layer of bituminised felt, while in modern properties a breathable membrane, such as Tyvek, is normally used. In this case the sarking is of a modern breathable membrane. It was found to be in a mostly undamaged condition and is considered to be suitable for its purpose.</p> <p>The roof space is laid with 200-300mm of wool type insulation at joist level. This is close to the current recommendation of 270mm for maximum energy efficiency. It does, however, limit movement and storage within the roof space as any supporting joists are concealed. It is also noted that the insulation is laid quite unevenly and should be redistributed.</p> <p>High moisture levels within roof spaces are responsible for the promotion of the development of timber defects such as rot and infestations by wood boring insects (commonly known as woodworm). Wood moisture content readings taken were found to be well within normal limits and below the levels normally required for this type of defect.</p> <p>No specific repairs are required. However, it is important to ensure that spaces remain well ventilated so as to reduce the likelihood of the development of defects such as rot and infestations by wood boring insects. In many cases, ventilation derives from openings at the eaves at the edge of the roof, though these can become blocked where insulation is forced into the spaces. When adding or replacing insulation, make sure that good ventilation is maintained.</p> <p>If installing extractor fans, make sure that hoses passing through the roof space extend to an external grille so that warm moist air is not ventilated into the roof.</p> <p>Care should be taken when moving around, or storing heavy objects, in the roof space. The spaces between the floor joists will not support a person's weight, or that of large boxes etc. Where heavy items are to be stored it is important to distribute the weight evenly using fixed boards. Additional structural support may be required if you plan to store large quantities of heavy items in the roof space.</p> |

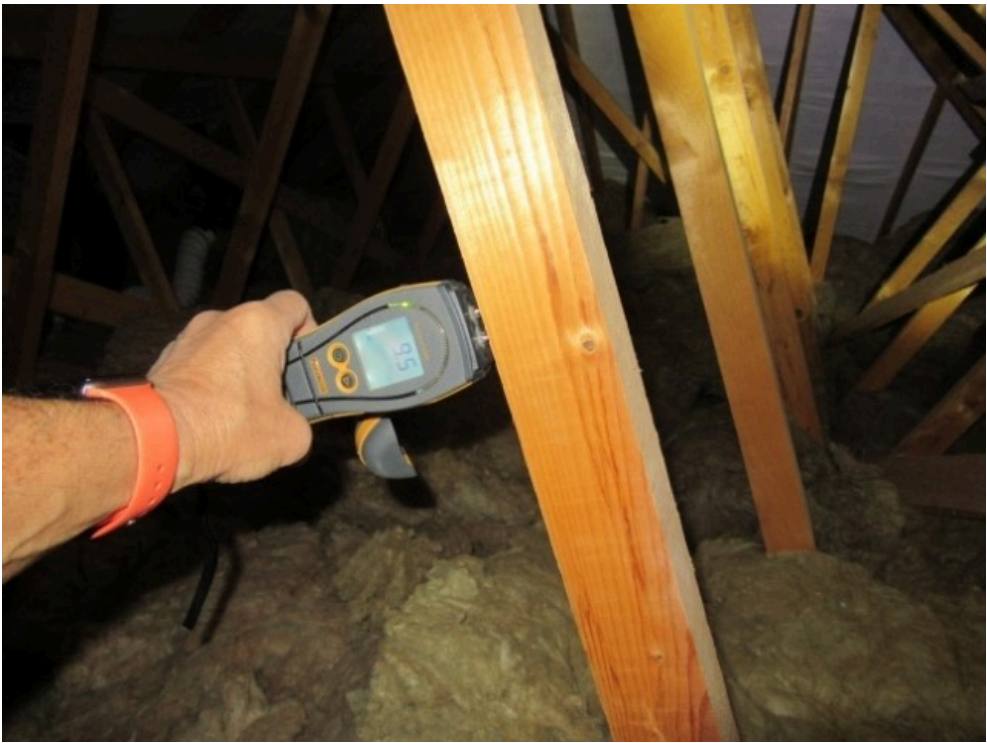
Normal moisture reading

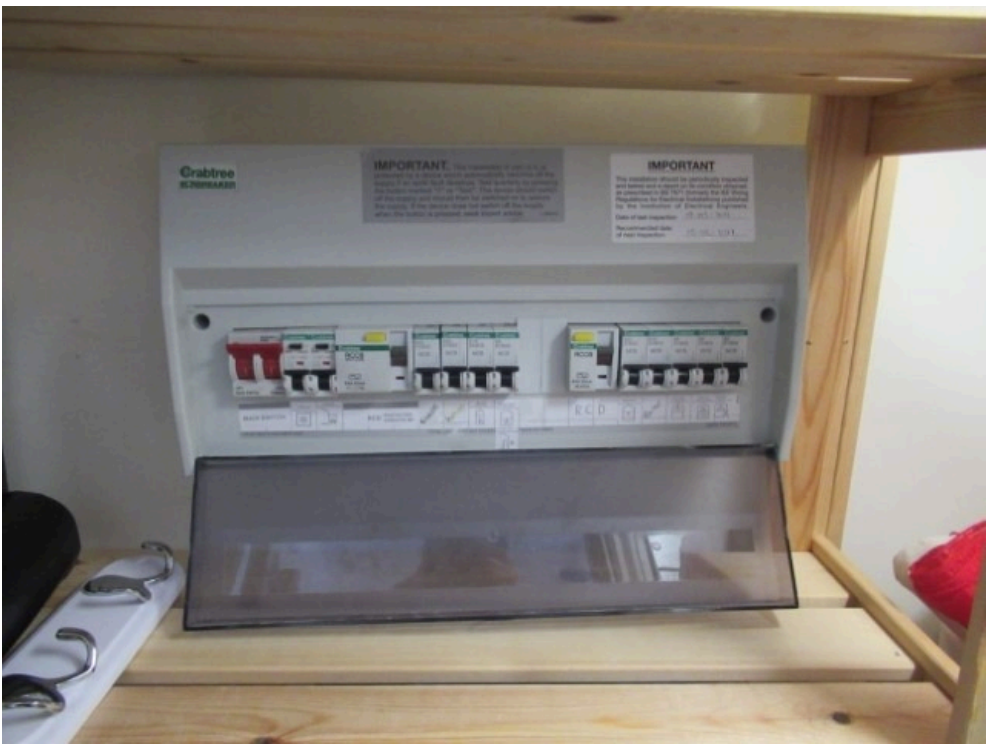
Consumer unit

| COMPANY<br>THUMBNAIL<br>HERE | 6.1 Electricity | Condition<br>rating | HS |
|---|---|---|---|
| <b>Condition</b> | <p>No evidence of broken, loose or damaged parts of the installation was seen, nor were any obvious amateur alterations or interventions noted. However, where furniture and other items are present many of the outlets can be hidden from view.</p> <p>As far as is known, the installation is exactly as it was laid at the time of the construction of the property in 2011, though there have been some minor spur additions made.</p> <p>As far as could be seen the visible wiring is of a modern PVC type, and no evidence was seen of any obviously dangerous issues, though many of the rooms were very full of boxes and other stored items, limiting the extent of the inspection.</p> <p>NAPIT recommends that domestic electrical installations are inspected and tested every 10 years in line with IET (The Institution of Engineering &amp; Technology) Guidance Note 3 covering Electrical Installation Condition Reports (EICR). This guidance also recommends that at any change of occupancy (such as a house sale, or change of tenant) an Electrical Installation Condition Report is carried out to prove the installation to be in a satisfactory or unsatisfactory condition. This report should cover all the fixed wiring and equipment within the property boundaries, including outbuildings.</p> <p>You can get further information from the Electricity Safety First.</p> <p>Any electrical works carried out should have been completed by a Registered Competent Person (Electrical) and, as such, would have provided a Minor Electrical Installation Works Certificate, or an Electrical Installation Certificate, and in addition a Building Regulation Compliance Certificate where required.</p> | | |

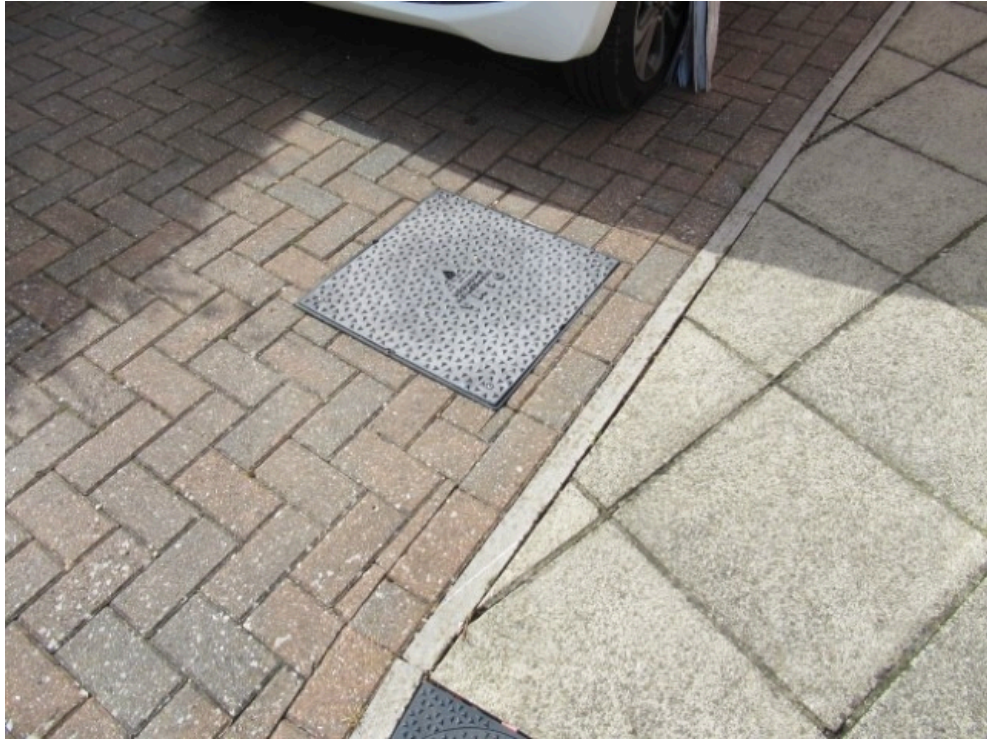
Inspection chamber in the drive

| COMPANY<br>THUMBNAIL<br>HERE | 6.5 Drainage | Condition<br>rating | 1 |
|---|---|---|---|
| <b>Condition</b> | <p>Water was seen to run through the chamber with no blockages or undue levels of silt being apparent. The direction of flow was from the house, through the chamber in the drive, and out to the road, presumably to a shared sewer.</p> <p>It is often suggested that the manholes only allow inspection of 5-10% of an entire drainage installation. As such, it is entirely possible that damage can be present within the system but which would not be apparent from opening the manholes.</p> <p>The only way to confirm the condition of the whole installation is to commission a CCTV inspection from a qualified contractor, for example a member of the National Association of Drainage Contractors at <a href="http://www.nadc.org.uk/">www.nadc.org.uk/</a></p> <p>Drains should be regularly inspected to ensure they remain free from blockages, tree root damage or other obstructions.</p> | | |

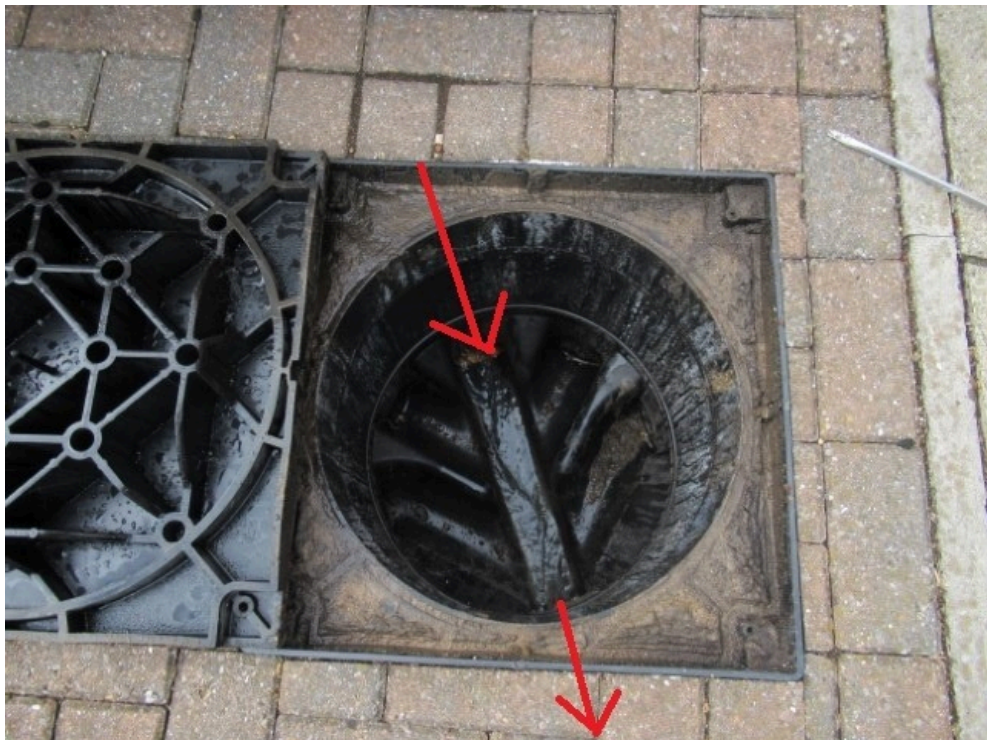
Garage is to top of picture with the flow direction indicated

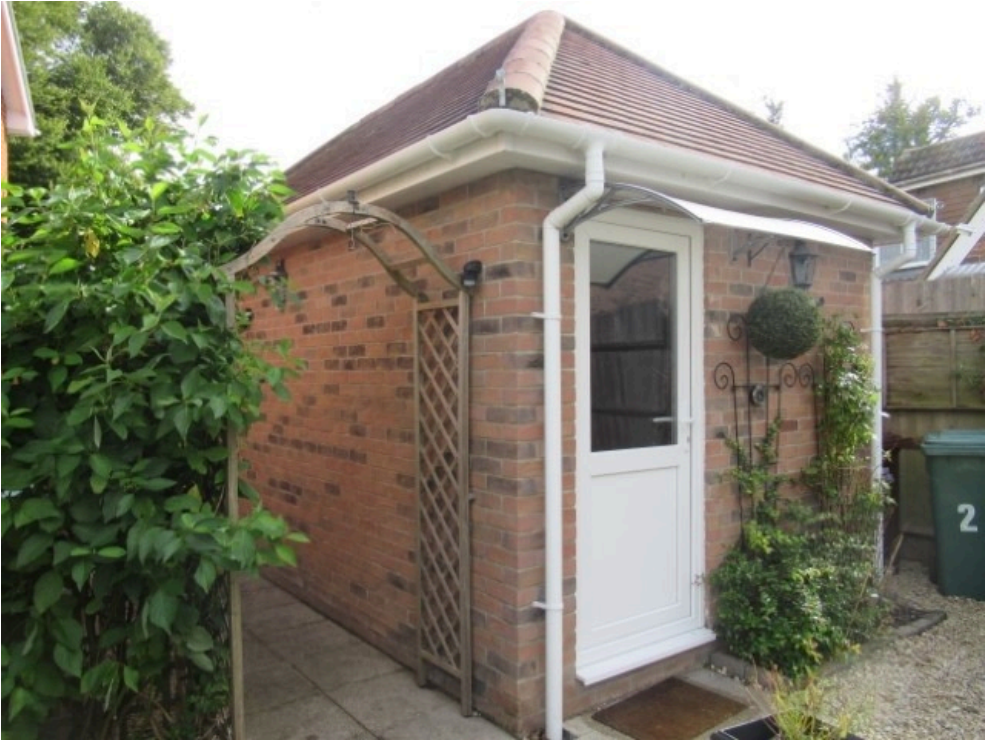
| COMPANY<br>THUMBNAIL<br>HERE | 7.1 Garaging | Condition<br>rating | 1 |
|---|---|---|---|
| Condition | The garage is in a stable condition with no evidence of any significant cracking or other unusual movement.<br>Both doors were found to operate normally<br>Normal maintenance is required. | | |
